Inspection Report

Property Address:

sample
Sample BC

Homegauge B.C. Ltd.

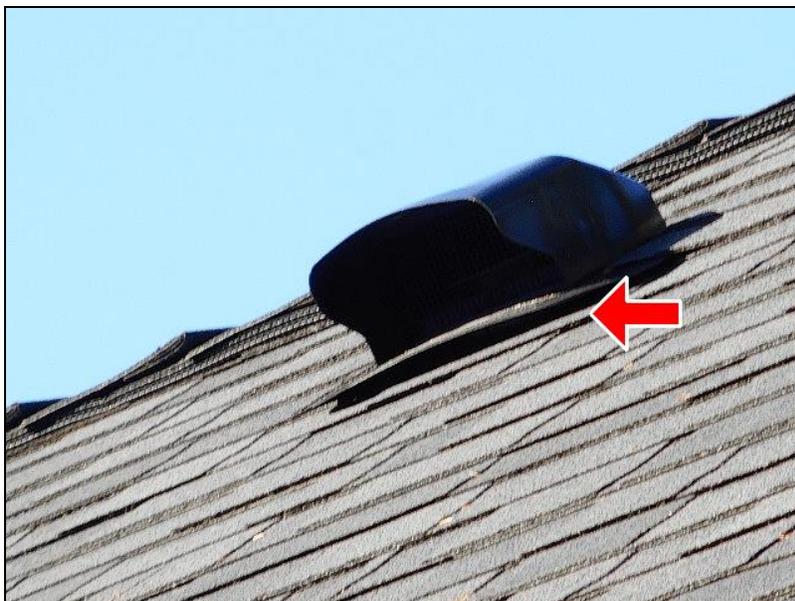
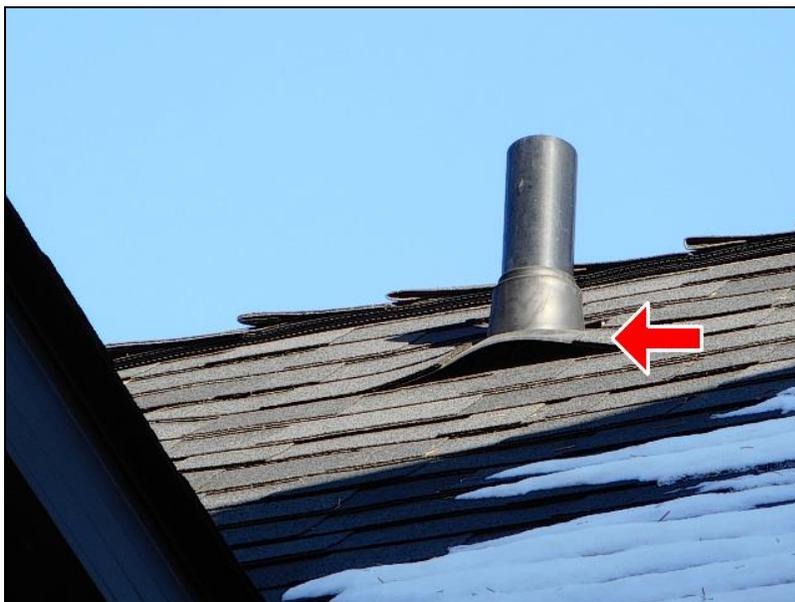
5. Snow cover obstructed view in some areas preventing proper assessment. Visible areas indicate roofing is installed well overall except a few small areas around roof penetrations need minor repair to lay roofing flat.

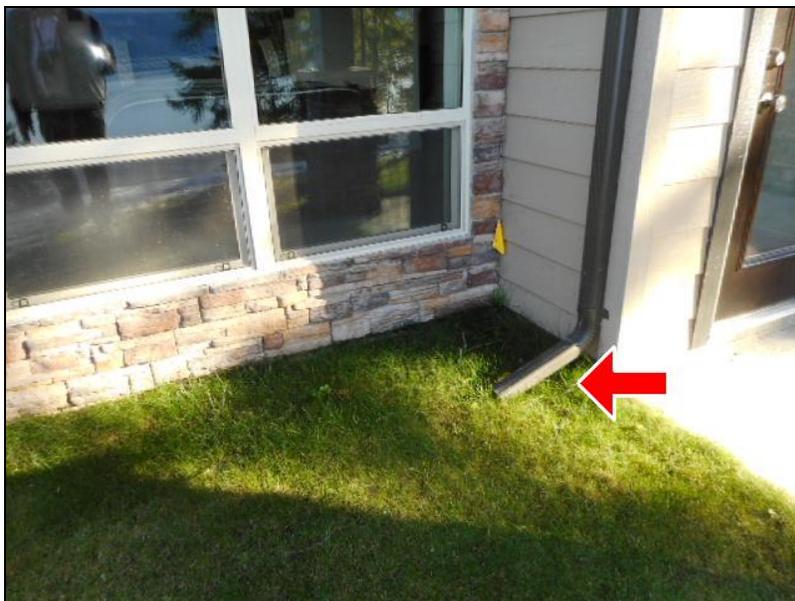
Item 6 - Item 1(Picture)

6. Overall condition of the gutters and downspouts appeared serviceable except discharge is in close proximity to foundations which is undesirable. Downspout extensions should be extended to discharge roof drainage well away from foundation to minimize potential for water accumulation at foundation and infiltration into crawlspace or living area, especially when ground is frozen and snow/ice accumulation may cause damming preventing adequate surface drainage away from home. Please review attachment at end of report.

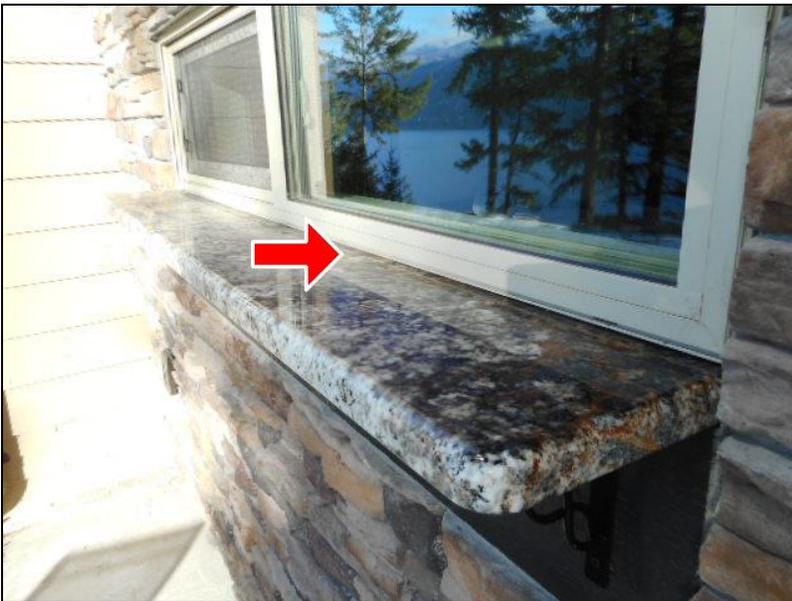
Item 7 - Item 1(Picture)

7. The exterior wall coverings, trim, flashings and caulking appeared serviceable overall except granite shelf needs to be caulked at window frame to minimize potential for moisture infiltration/deterioration behind cladding.

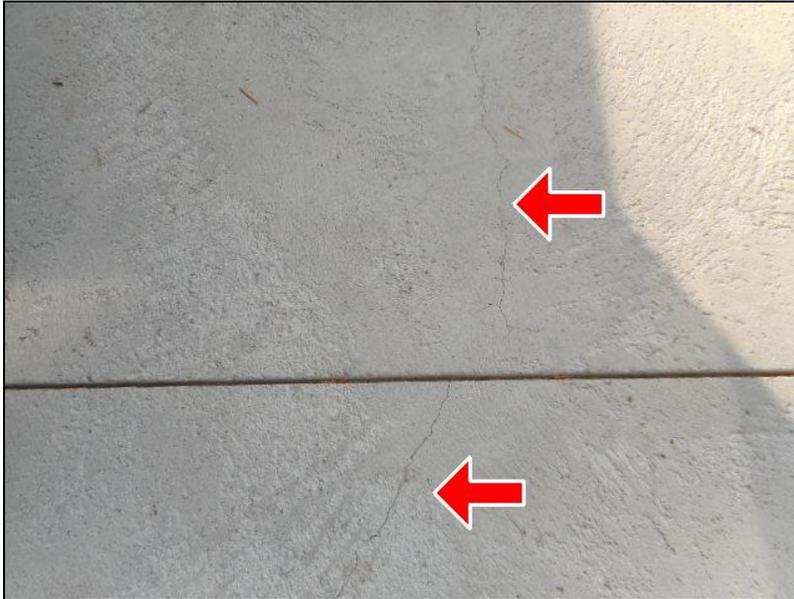
Item 8 - Item 1(Picture)

- 8. Complimentary views. The concrete patio slab appeared serviceable overall with typical minor shrinkage/settlement cracks present, which is common due to ground frost movement, but no concern was evident. This condition may progress over long term.

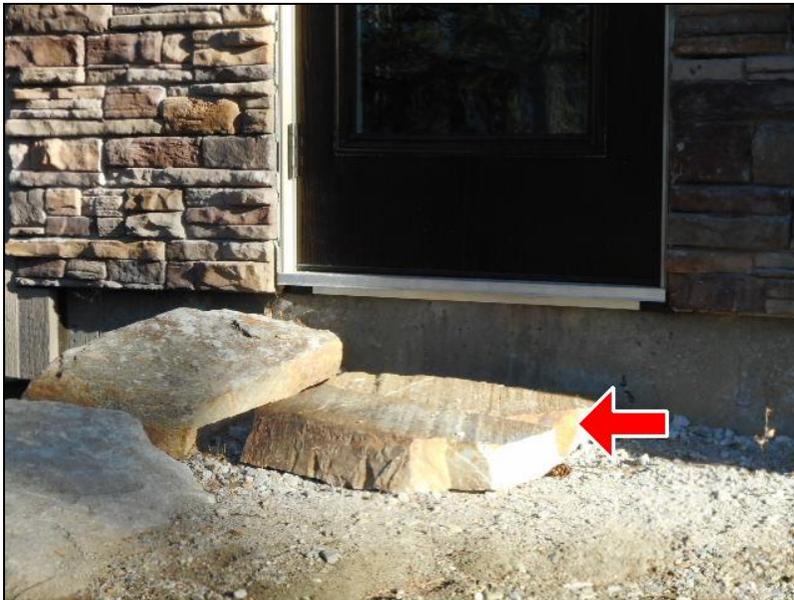
Item 9 - Item 1(Picture)

- 9. The uneven stone step at rear entry is a potential hazard. Installation of a secure step meeting minimum building code standard is needed.

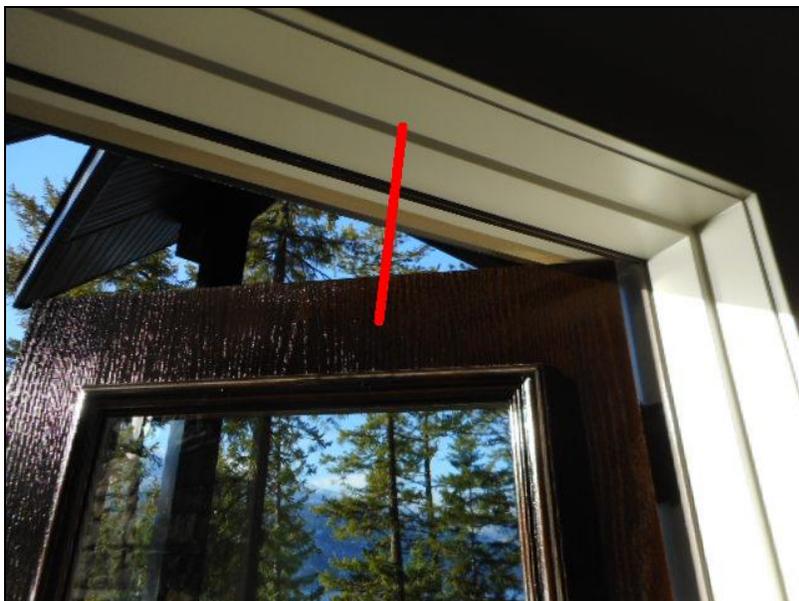
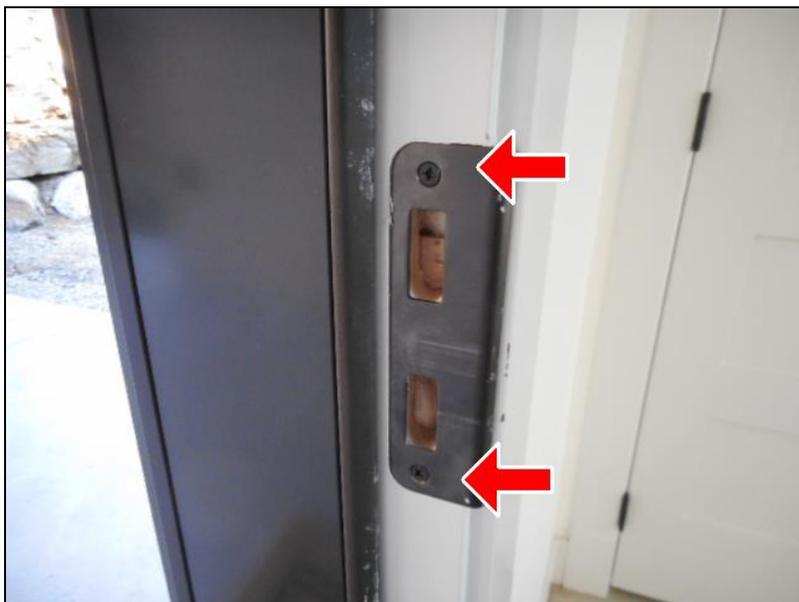
The entry doors and hardware functioned normally and appeared serviceable except the rear entry doors swing outward which will be prone to wind catching door causing it to open out of control with potential for damage or injury. Installation of a restraining device to limit door swing is recommended (i.e. wind chain/spring at red line in picture).

Installation of long screws to embed into adjacent wood stud is needed to meet building code at deadbolt strike plates and 1 screw in each hinge for improved security and to minimize potential for door sag caused by loosening screws over time.

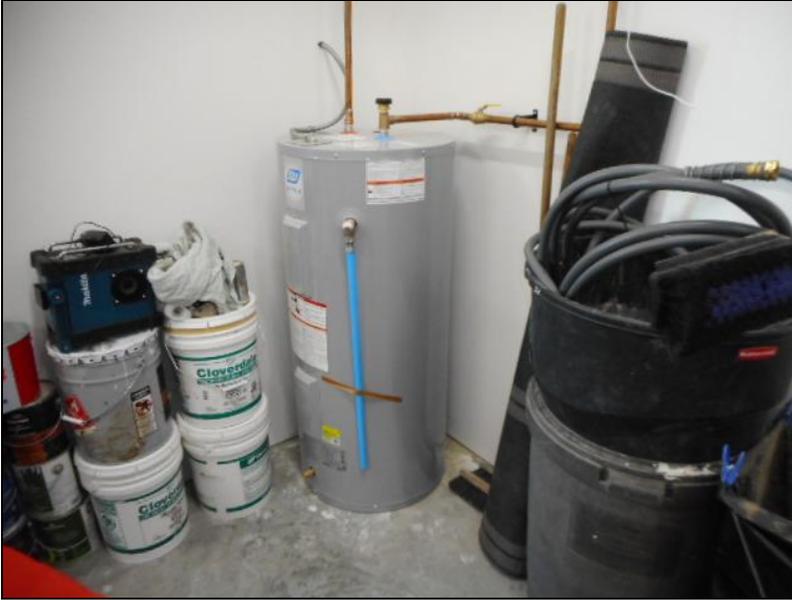
Item 13 - Item 1(Picture)

13. A water heater and exposed plumbing were present. Water heater should remain on during freezing months and garage must be maintained above freezing temperature to prevent frost damage and leaks.

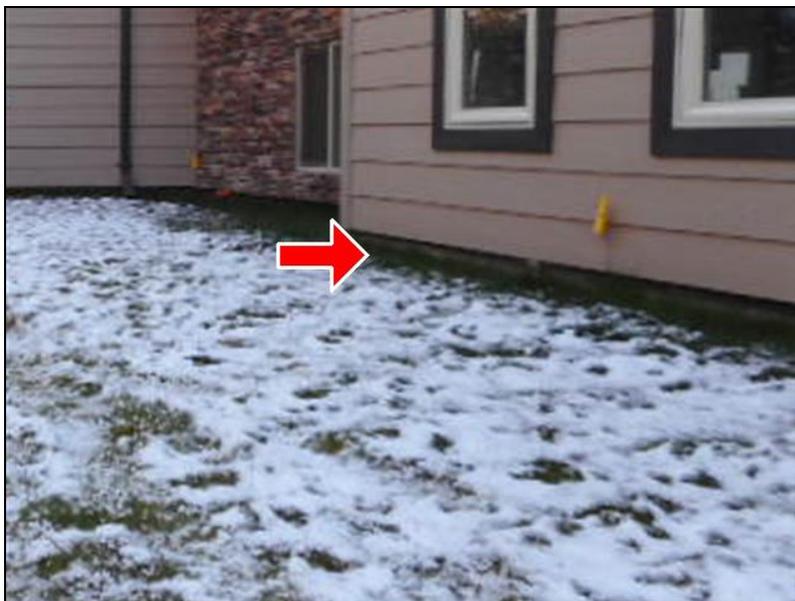
Item 15 - Item 1(Picture)

15. Less than the building code 6" minimum clearance from bottom of wall cladding to finished grade was observed in most areas with roof drainage discharging into areas which is potential concern for water accumulation and leaks into home. Regrading is needed in many areas to ensure adequate clearance from siding to grade to minimize potential for seasonal moisture infiltration, deterioration of cladding and/or structure and insect entry into home. This will require substantial modification/repair of the existing finished landscaping.

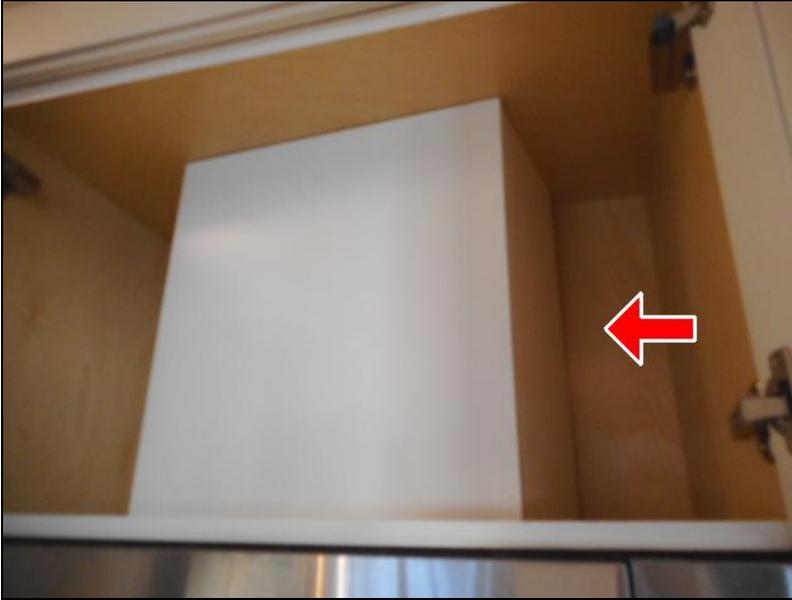
Item 17 - Item 1(Picture)

17. Cabinets appeared serviceable overall and doors and drawers functioned normally except the range exhaust venting enclosure was not secured in place. Minor repair/fastening needed.

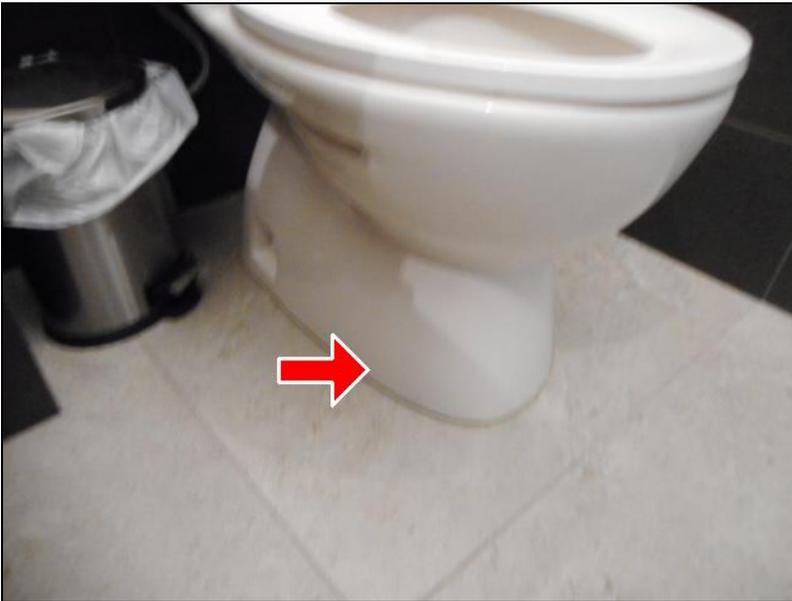
Item 19 - Item 1(Picture)

19. The toilet appeared serviceable and functioned normally except it was slightly loose/wobbled at base and should be shimmed as needed and refastened securely at toilet flange. This is recommended preventive maintenance as toilet movement may eventually cause seal to leak which may cause sewer gas to vent into room, deterioration of the subfloor or damage to finished ceiling below.

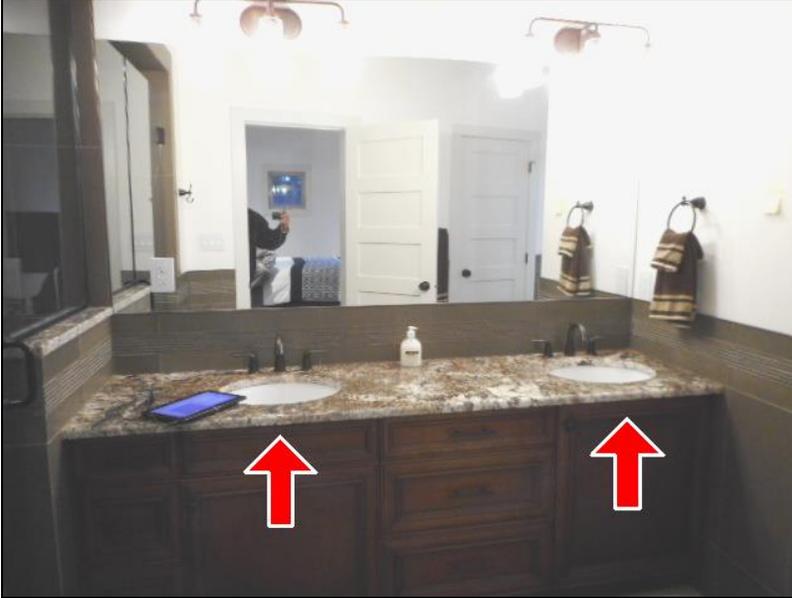
Item 20 - Item 1(Picture)

20. Sink base and cabinetry appeared serviceable and doors/drawers functioned properly except the cabinet, sinks and light fixtures are installed substantially out of position, contrary to the building plans which clearly show a symmetrical layout. Cabinets and counter replacement, plumbing and electrical changes, drywall repairs and repainting would be required to correct this nonconforming condition.

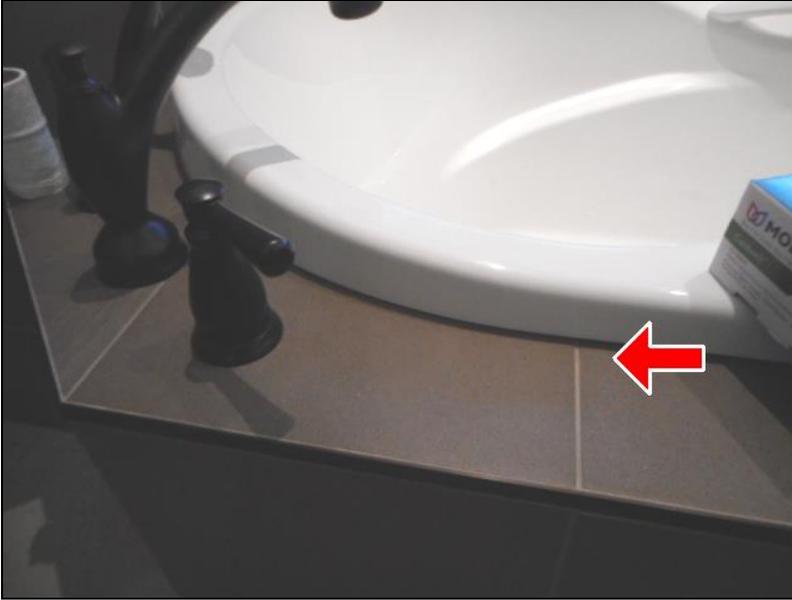
Item 21 - Item 1(Picture)

21. Silicone caulking along floor and inside corners at shower appeared serviceable but recommend silicone caulking around tub as minor preventative maintenance to minimize potential for spilled water migration/damage under tub and to facilitate cleaning.

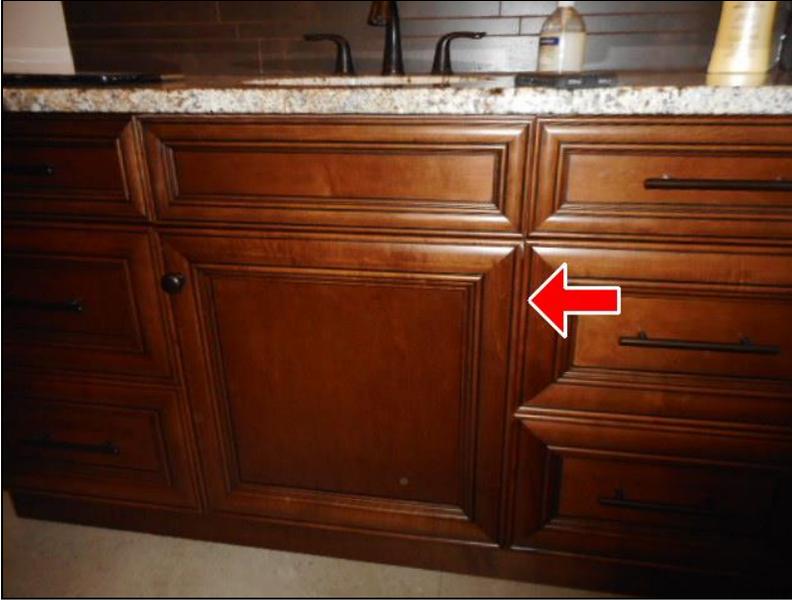
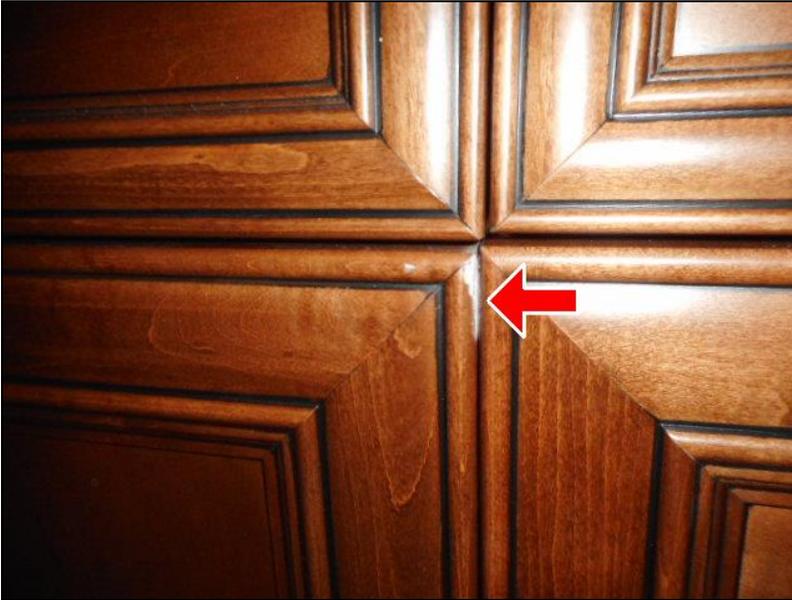
22. Sink base and cabinetry appeared serviceable and doors/drawers functioned properly except conflict with door/drawers is causing wear. Attempt to adjust door was unsuccessful. Realignment and adjustment of some drawers and door and touching up small damaged area is needed.

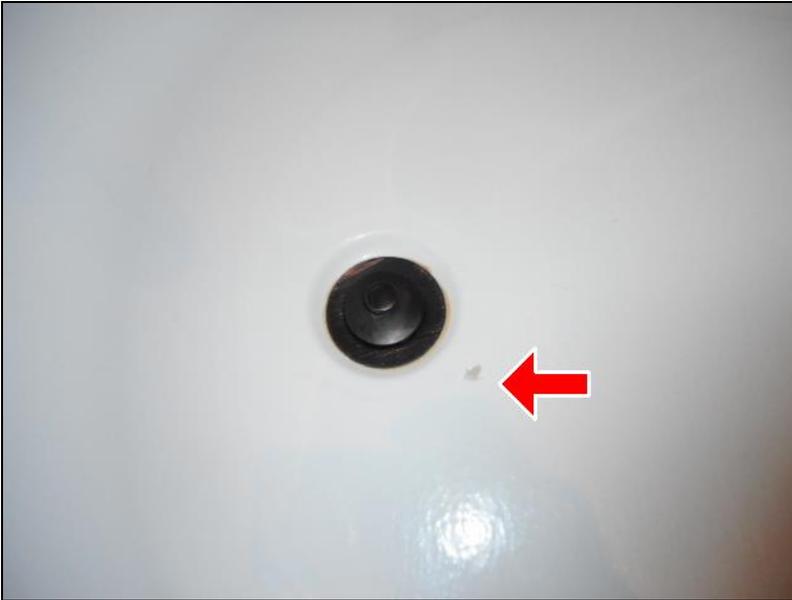
Item 23 - Item 1(Picture)

23. Overall condition of the plumbing fixtures appeared serviceable except the acrylic tub has small chip which will need professional repair.

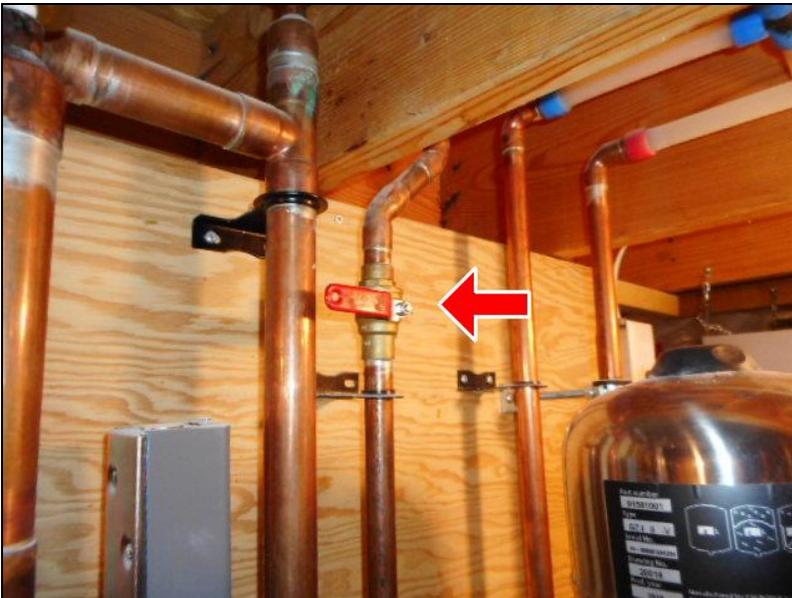
Item 24 - Item 1(Picture)

Note: This valve and water pump power supply should be shut off whenever the home is vacant for any length of time to minimize damage in the event of a water leak.

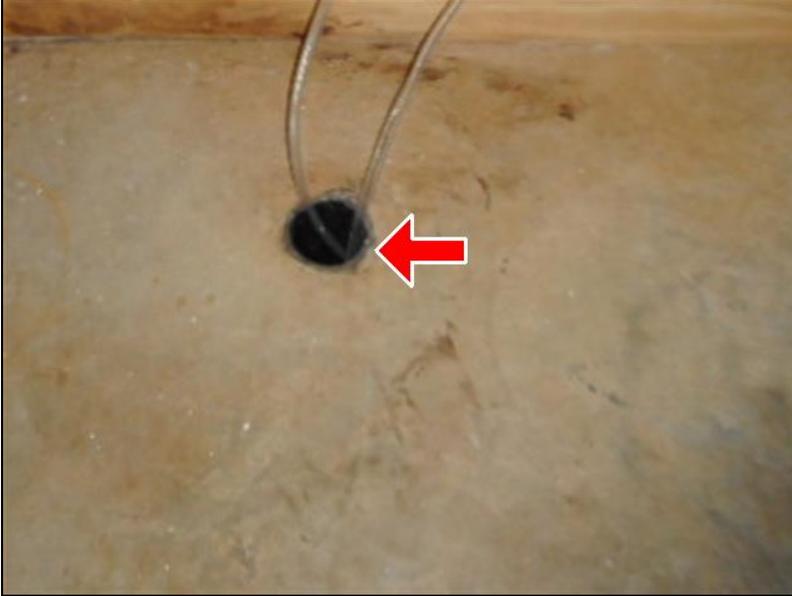
Item 26 - Item 1(Picture)

26. Floor drain was found adjacent to water heater but should have a drain cover installed to prevent large objects/debris entering/plugging drain.

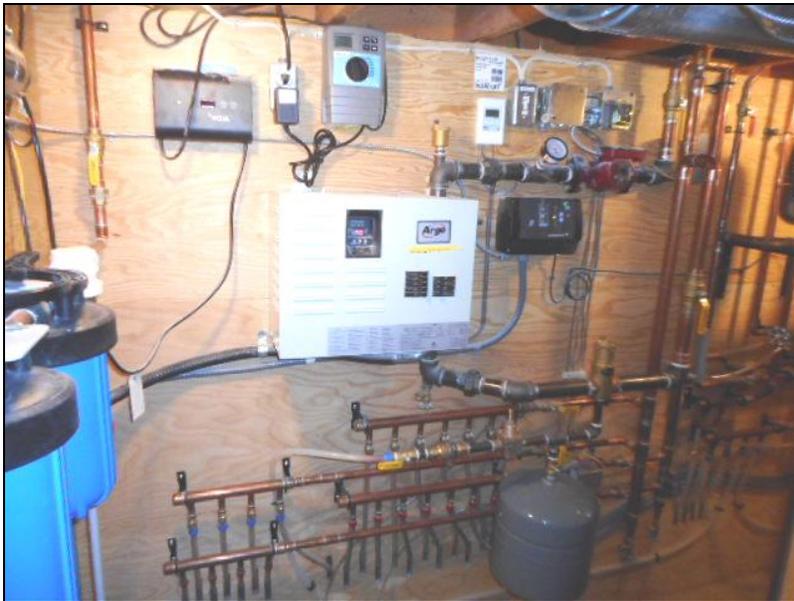
Item 28 - Item 1(Picture)

28. The main heating system is a circulating boiler providing heating to main domestic water heater and the hydronic in floor heating equipment system in main floor areas which is a multi zone system. System operated normally and appears in serviceable condition with no concern evident but is complex. A qualified heating contractor familiar with this system should be retained to provide familiarization and operating procedures to owner.

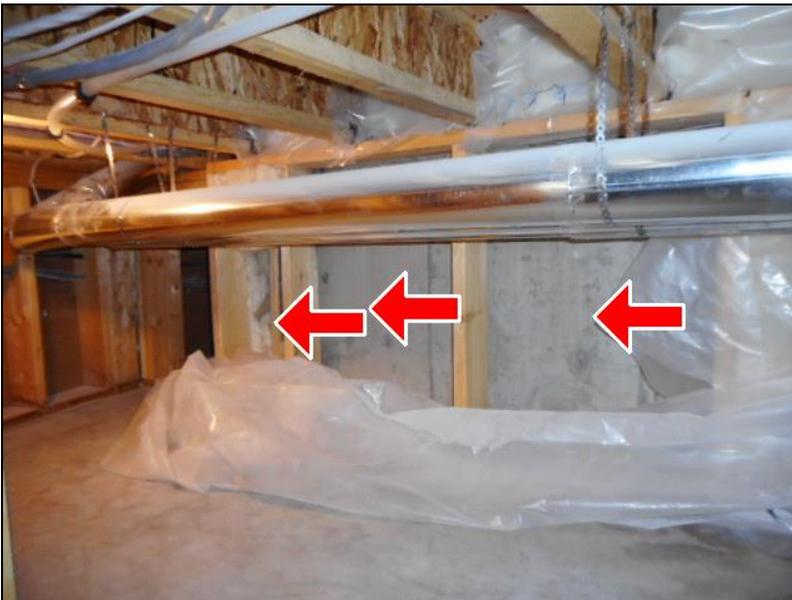
Item 30 - Item 1(Picture)

30. Most areas were covered preventing inspection. Foundation had wood framing with vapor barrier and fiberglass insulation installed in finished areas, confirmed at several light switches or outlets chosen randomly and scan with infrared camera except small area of incomplete insulation and vapor barrier needs finishing in crawlspace area.

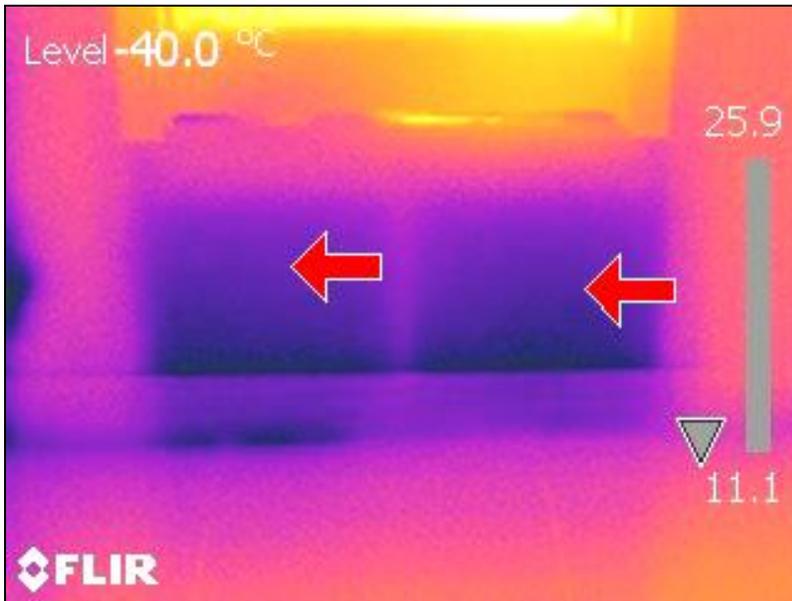
Item 31 - Item 1(Picture)

31. All walls were covered restricting inspection. Exterior walls are 2 x 6 wood framed with vapor barrier and fiberglass insulation found by probing with wire at several light switches or outlets chosen randomly and scan with infrared camera except small area of wall below fireplace does not appear to be insulated which could result in

condensation and mold growth during cold weather. Installing insulation is needed which will require repairing drywall and repainting area.

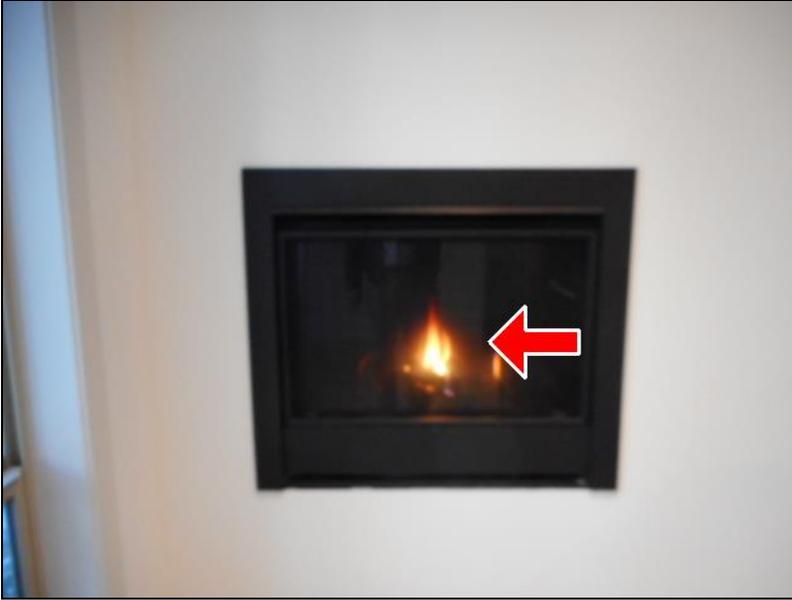
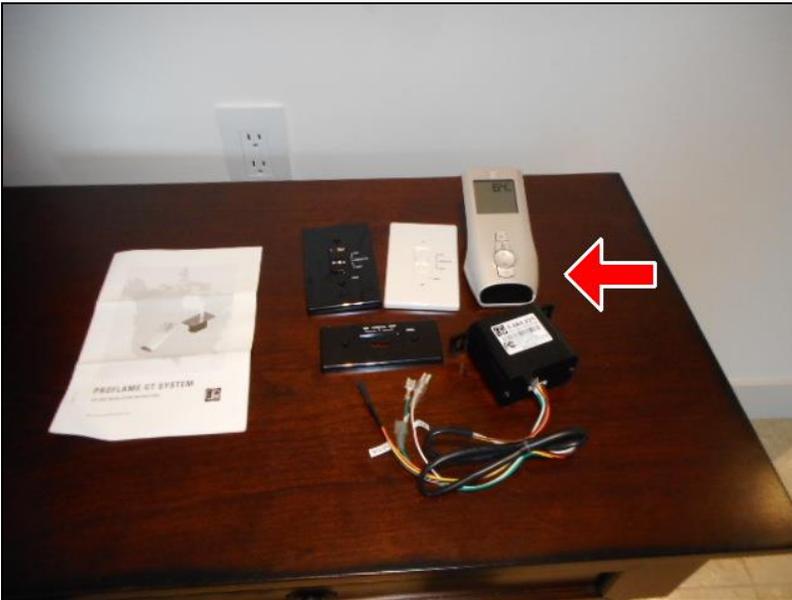
32. Direct vent gas fireplace functioned normally with no concern evident except control is thermostat on wall which functioned normally with no concern evident but fireplace was supplied with remote control device which should be installed per owners preference. Soot/deposits buildup on interior of glass front indicate poor combustion. Recommend a qualified heating contractor service and adjust as required.

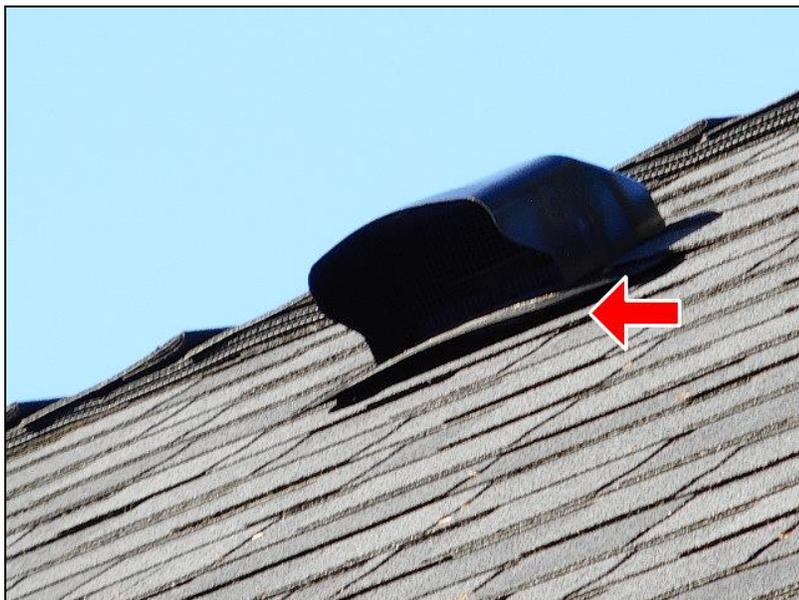
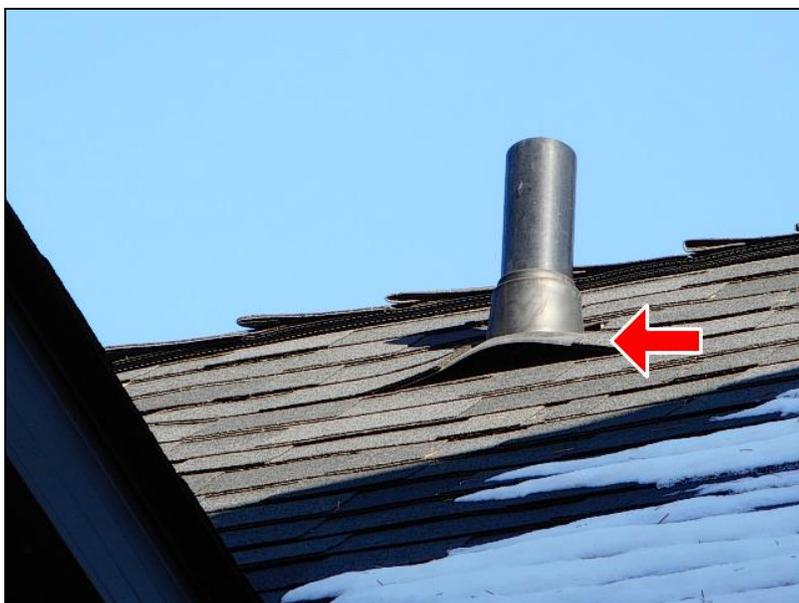
Snow cover obstructed view in some areas preventing proper assessment. Visible areas indicate roofing is installed well overall except a few small areas around roof penetrations need minor repair to lay roofing flat.

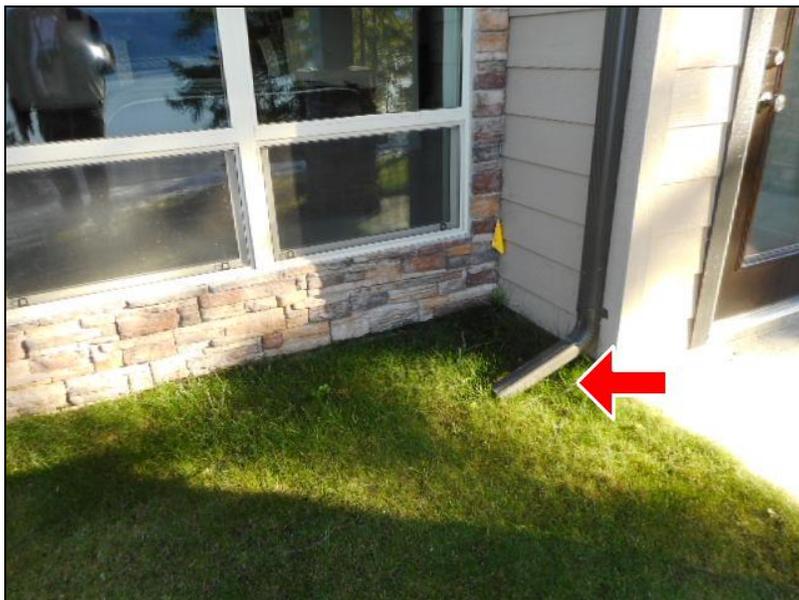
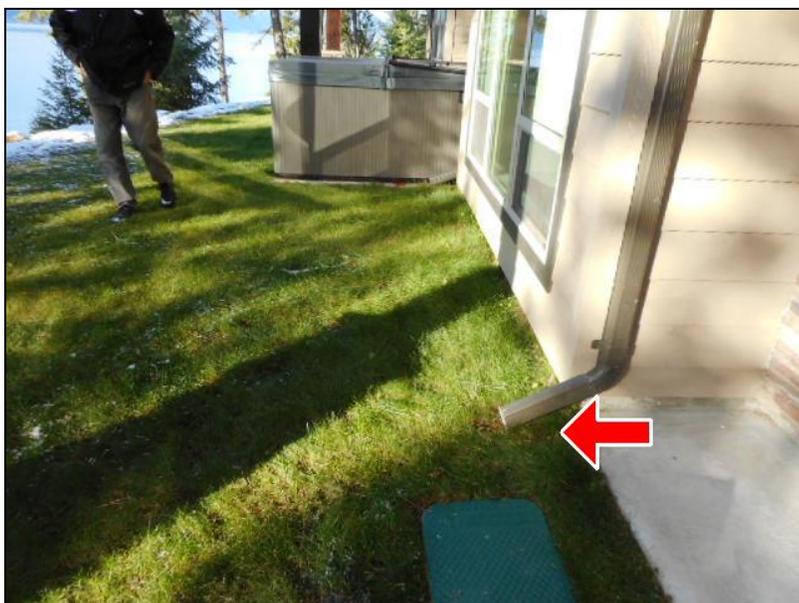
Overall condition of the gutters and downspouts appeared serviceable except discharge is in close proximity to foundations which is undesirable. Downspout extensions should be extended to discharge roof drainage well away from foundation to minimize potential for water accumulation at foundation and infiltration into crawlspace or living area, especially when ground is frozen and snow/ice accumulation may cause damming preventing adequate surface drainage away from home. Please review attachment at end of report.

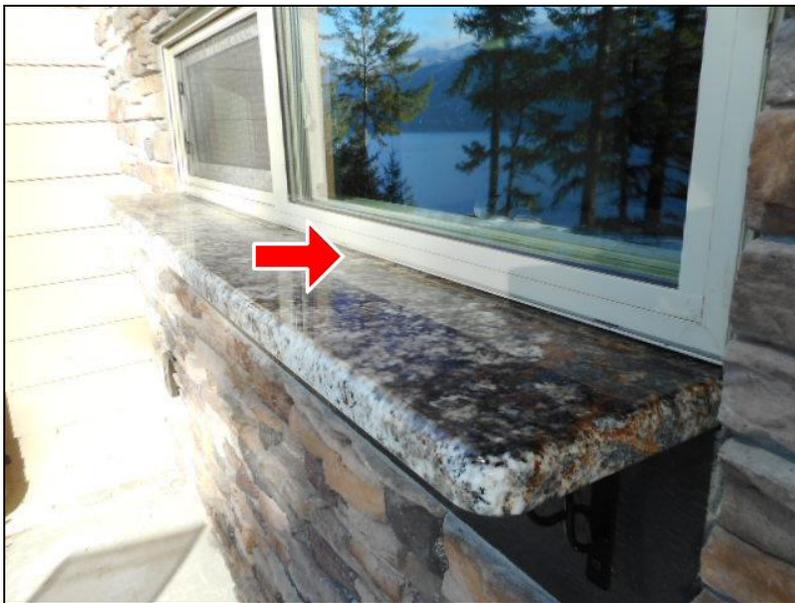
3.1 Item 1(Picture)

The exterior wall coverings, trim, flashings and caulking appeared serviceable overall except granite shelf needs to be caulked at window frame to minimize potential for moisture infiltration/deterioration behind cladding.

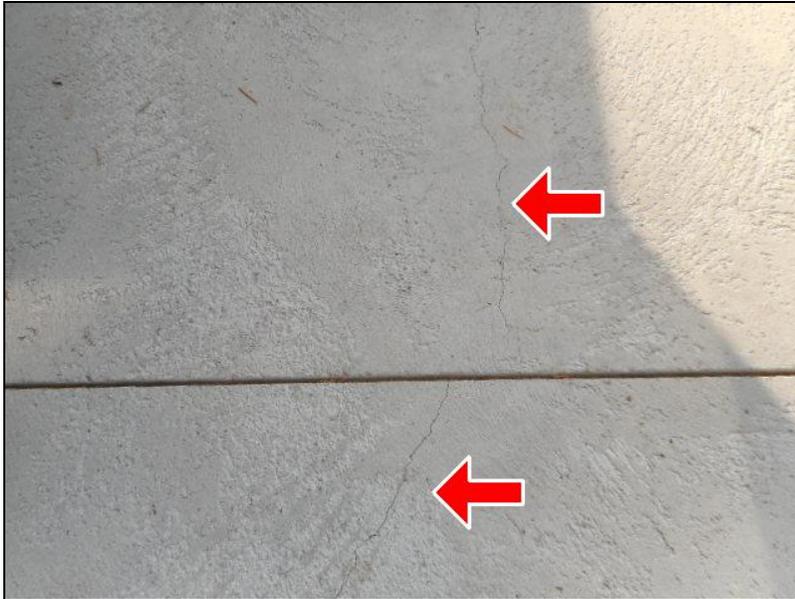
4.0 Item 1(Picture)

Complimentary views. The concrete patio slab appeared serviceable overall with typical minor shrinkage/settlement cracks present, which is common due to ground frost movement, but no concern was evident. This condition may progress over long term.

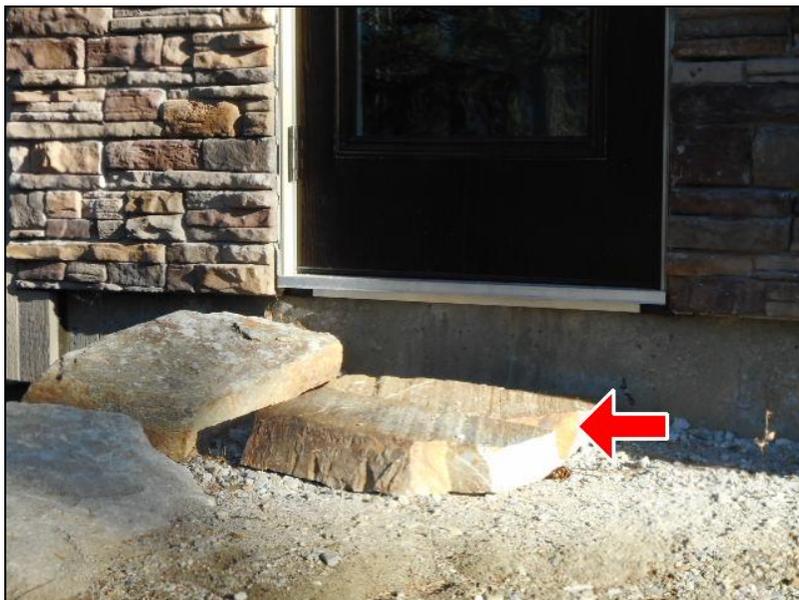
4.3 Item 1(Picture)

The uneven stone step at rear entry is a potential hazard. Installation of a secure step meeting minimum building code standard is needed.

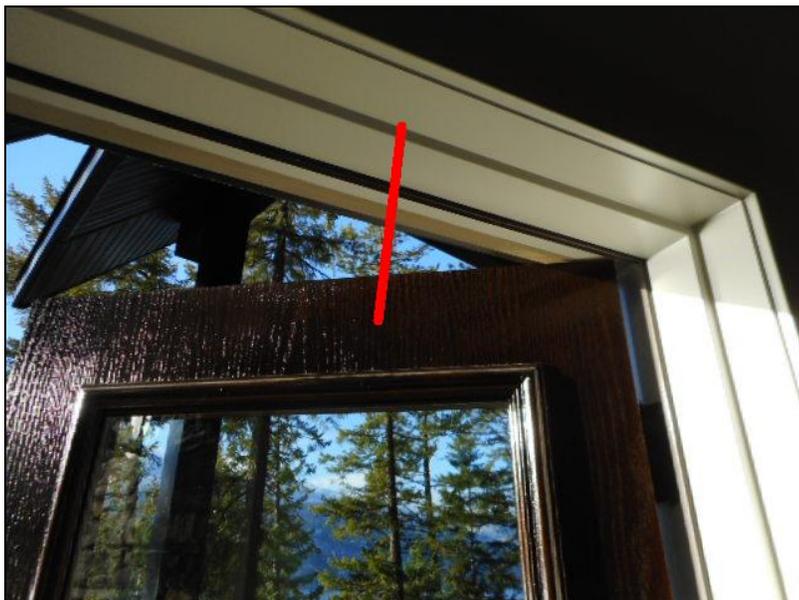
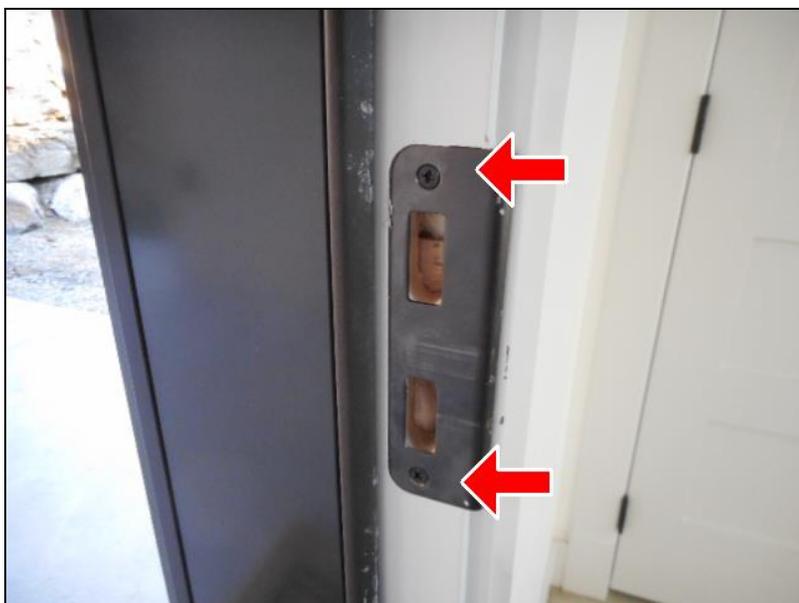
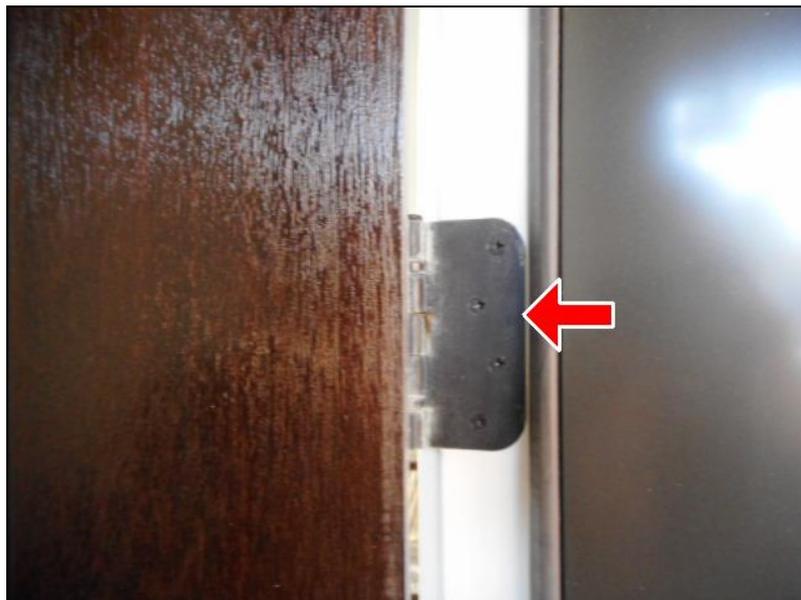
The entry doors and hardware functioned normally and appeared serviceable except the rear entry doors swing outward which will be prone to wind catching door causing it to open out of control with potential for damage or injury. Installation of a restraining device to limit door swing is recommended (i.e. wind chain/spring at red line in picture).

Installation of long screws to embed into adjacent wood stud is needed to meet building code at deadbolt strike plates and 1 screw in each hinge for improved security and to minimize potential for door sag caused by loosening screws over time.

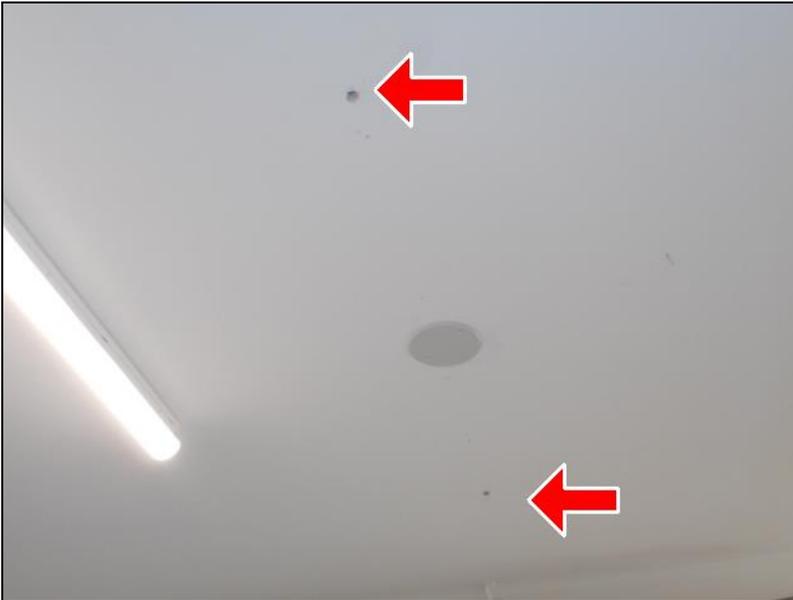
6.1 Item 1(Picture)

The garage interior appeared serviceable overall except holes at previous light fixture location need to be patched/repainted and water piping penetration of ceiling needs to be sealed to comply with building code requirement for fume separation between garage and living area.

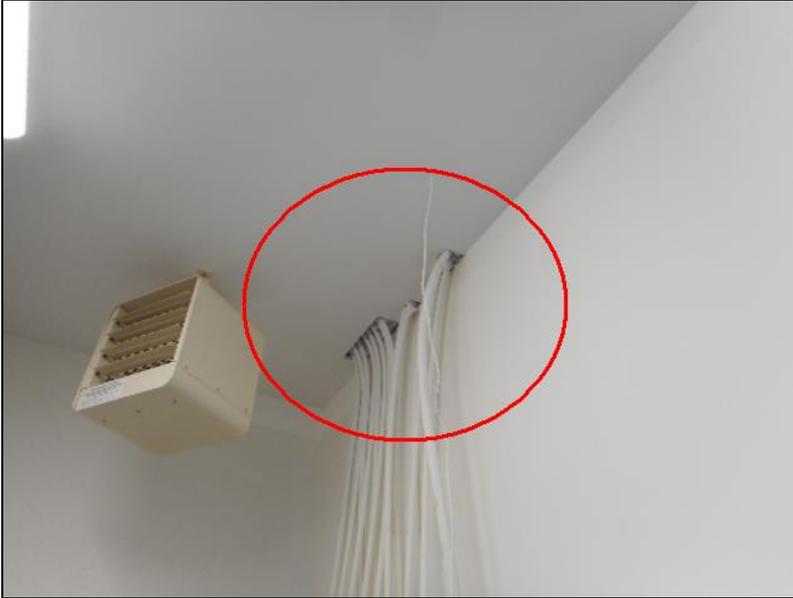
6.8 Item 1(Picture)

Smoke/fume separation between garage and living areas appeared serviceable overall except plumbing penetration at ceiling needs to be sealed and the door from the garage to the interior of the home requires adjustment of the spring hinges and door hardware to ensure door automatically closes and latches shut to to comply with building code requirement for fume separation between garage and living area.

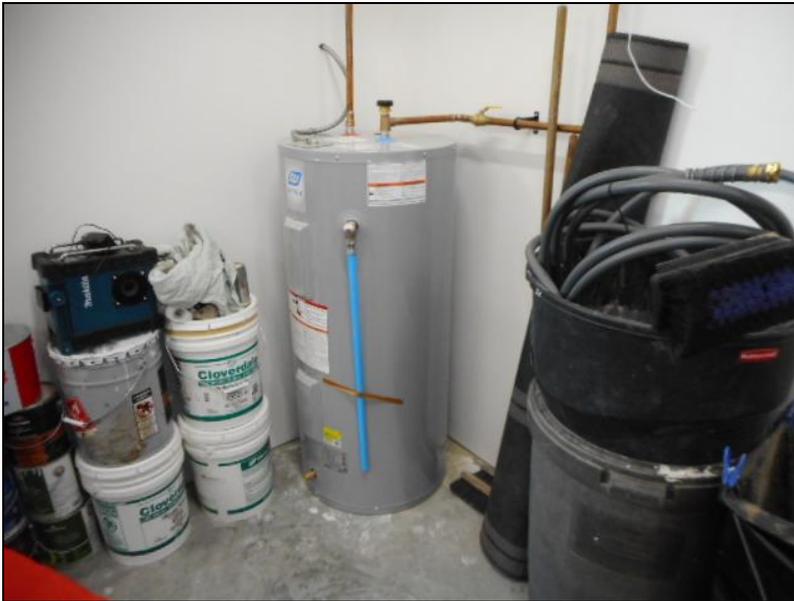
6.11 Item 1(Picture)

A water heater and exposed plumbing were present. Water heater should remain on during freezing months and garage must be maintained above freezing temperature to prevent frost damage and leaks.

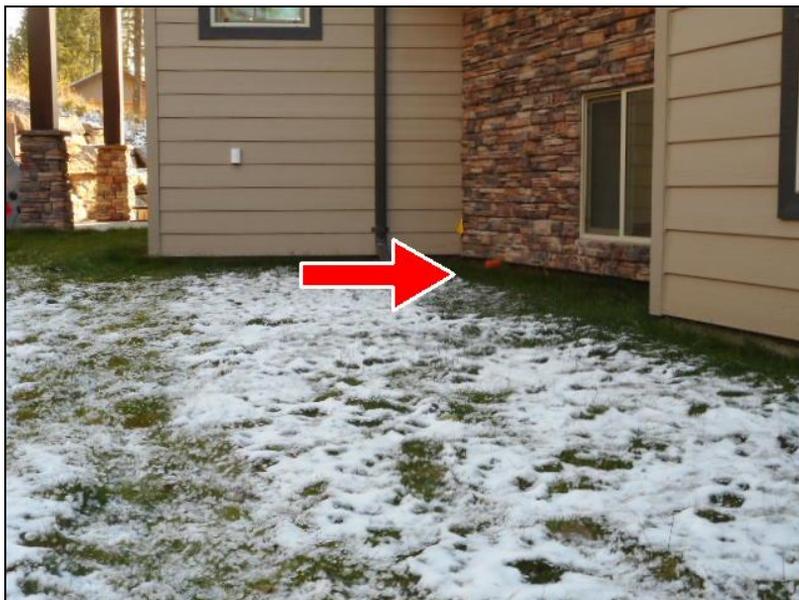
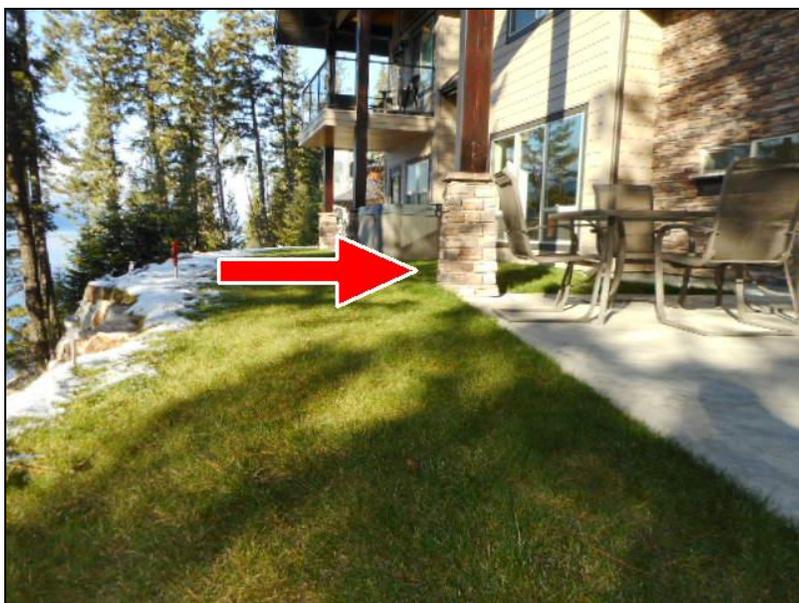
Note: 2 capped pipes were present which appear to be drain connections to foundation perimeter drain system. Caps should be removed and surface drains installed.
