Inspection Report

Property Address:

sample
Sample BC

Homegauge B.C. Ltd.

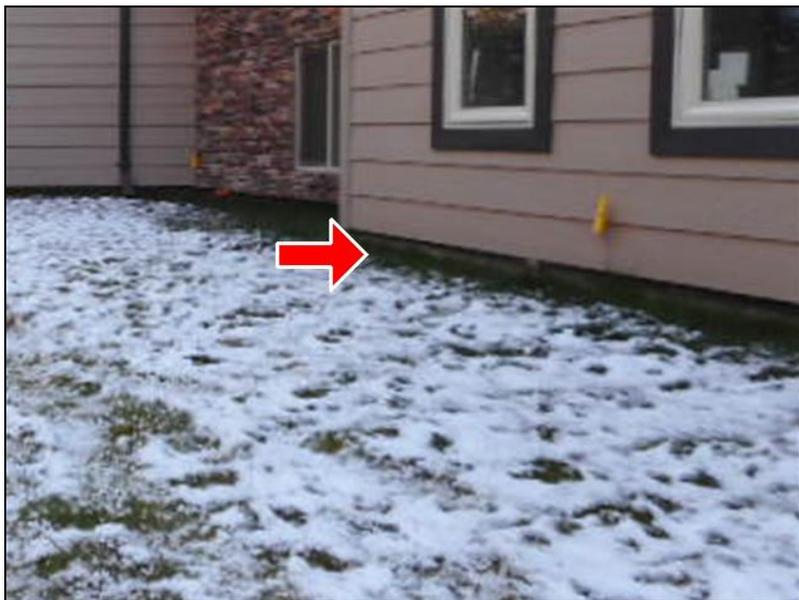
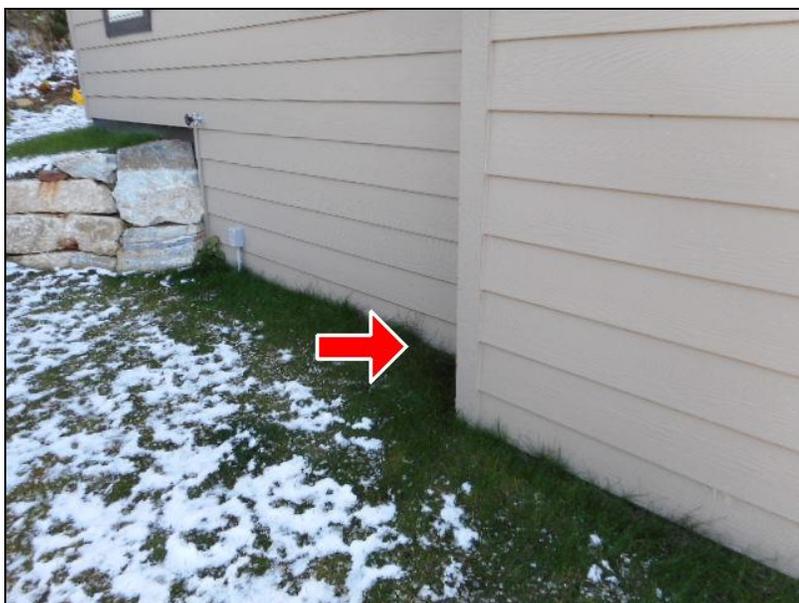
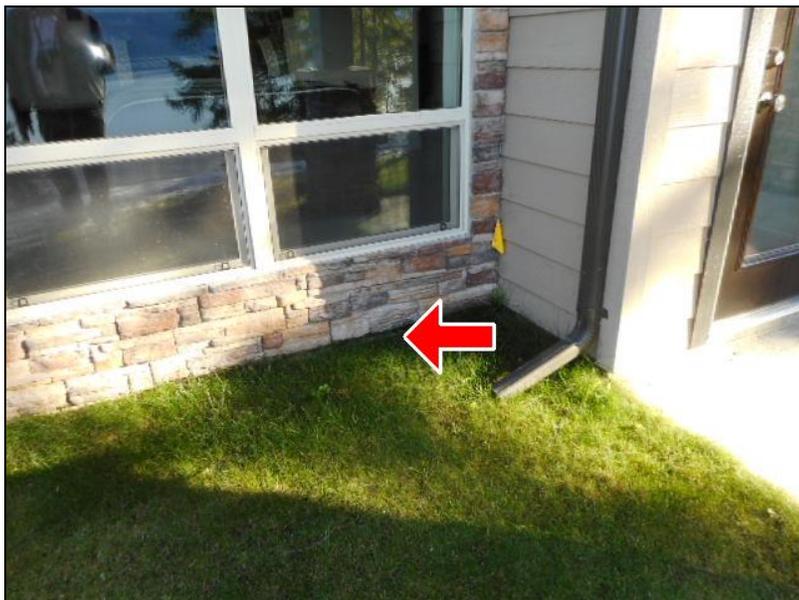
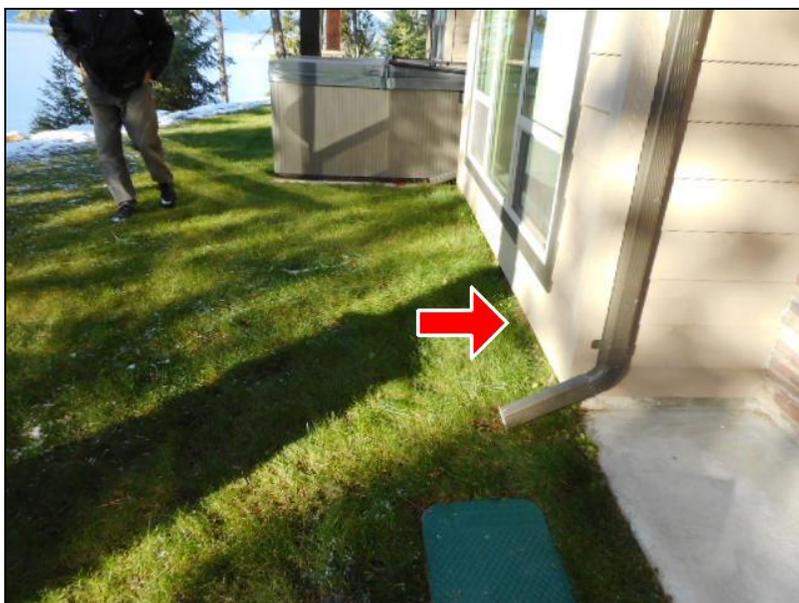
Less than the building code 6" minimum clearance from bottom of wall cladding to finished grade was observed in most areas with roof drainage discharging into areas which is potential concern for water accumulation and leaks into home. Regrading is needed in many areas to ensure adequate clearance from siding to grade to minimize potential for seasonal moisture infiltration, deterioration of cladding and/or structure and insect entry into home. This will require substantial modification/repair of the existing finished landscaping.

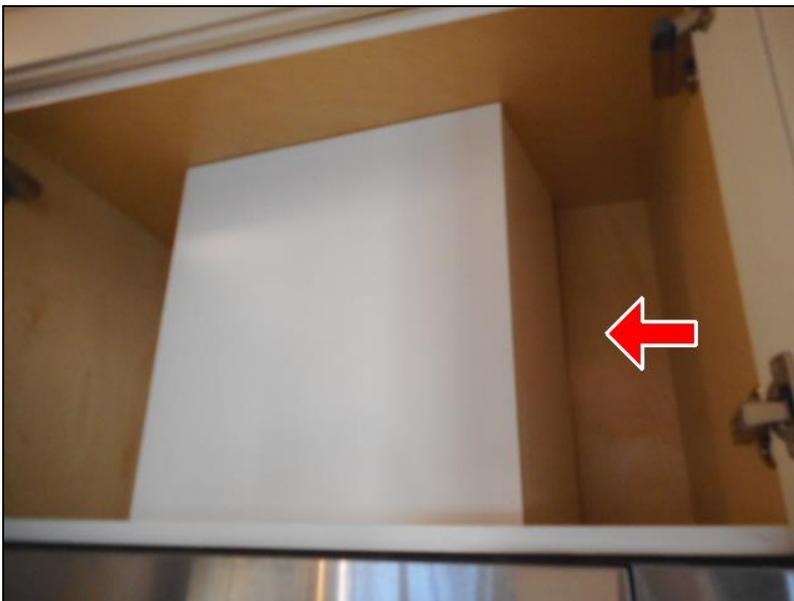
10.5 Item 1(Picture)

Cabinets appeared serviceable overall and doors and drawers functioned normally except the range exhaust venting enclosure was not secured in place. Minor repair/fastening needed.

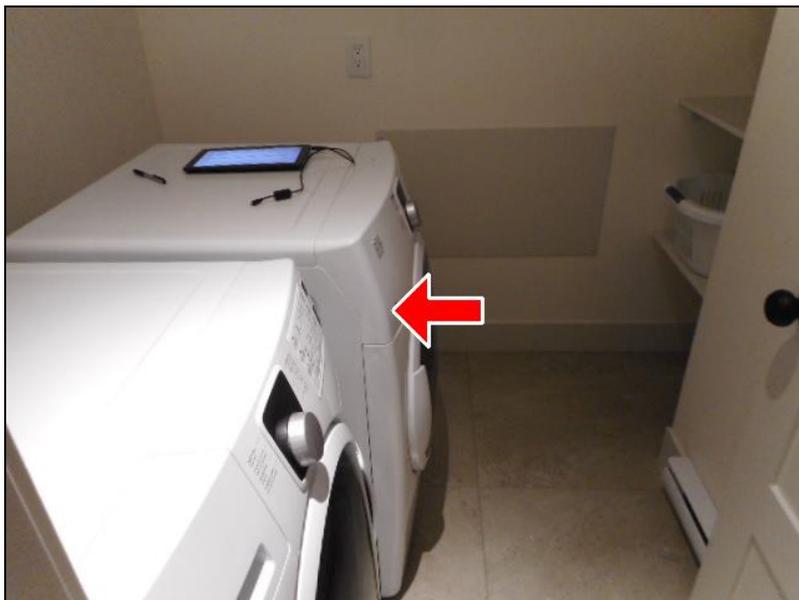
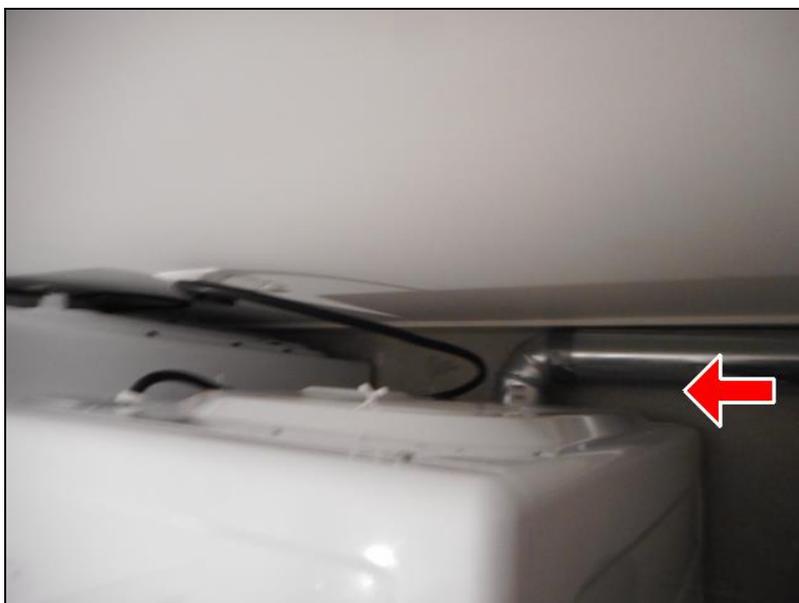
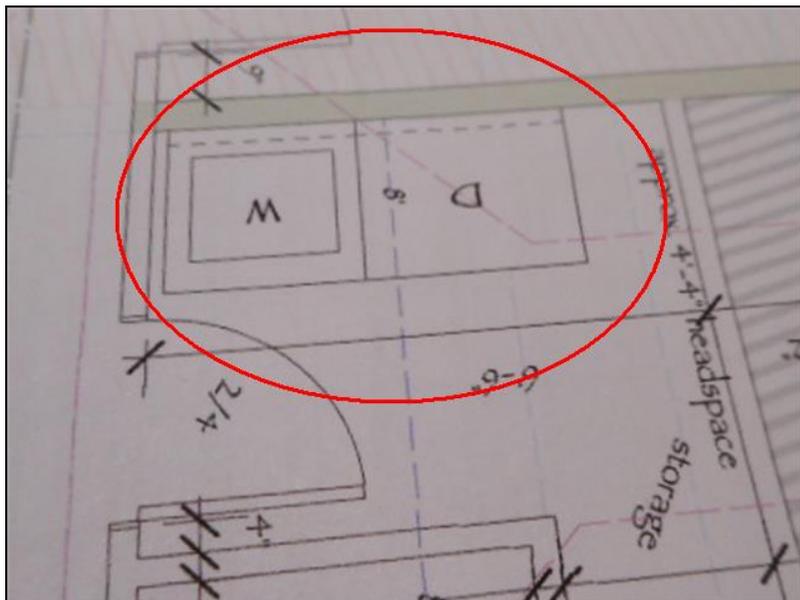
Dryer power appeared serviceable and vents are ducted to exterior vent hoods but the venting in laundry room has been installed within room contrary to plan which show dryer close to wall which would require venting to be recessed in wall which is a common detail. This has forced dryer to be installed out of alignment with washer and approximately 6" forward which encroaches on limited space in this room. Correction to comply with drawings will require wall and exterior modifications and refinishing.

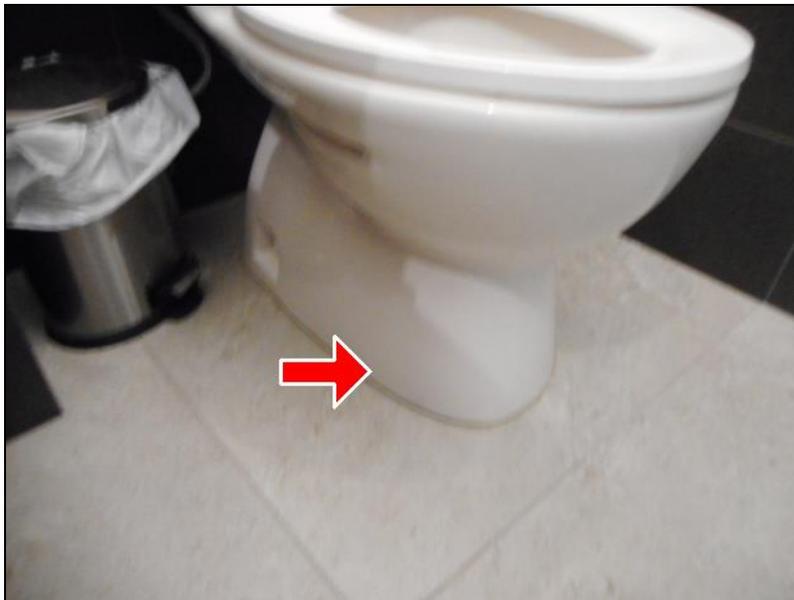
15.6.B Item 1(Picture)

The toilet appeared serviceable and functioned normally except it was slightly loose/wobbled at base and should be shimmed as needed and refastened securely at toilet flange. This is recommended preventive maintenance as toilet movement may eventually cause seal to leak which may cause sewer gas to vent into room, deterioration of the subfloor or damage to finished ceiling below.

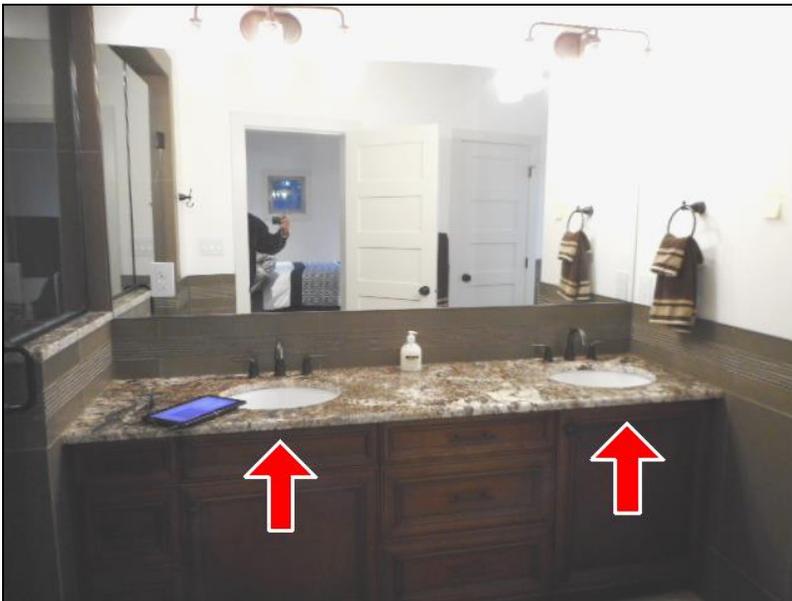
15.0.C Item 1(Picture)

Sink base and cabinetry appeared serviceable and doors/drawers functioned properly except the cabinet, sinks and light fixtures are installed substantially out of position, contrary to the building plans which clearly show a symmetrical layout. Cabinets and counter replacement, plumbing and electrical changes, drywall repairs and repainting would be required to correct this nonconforming condition.

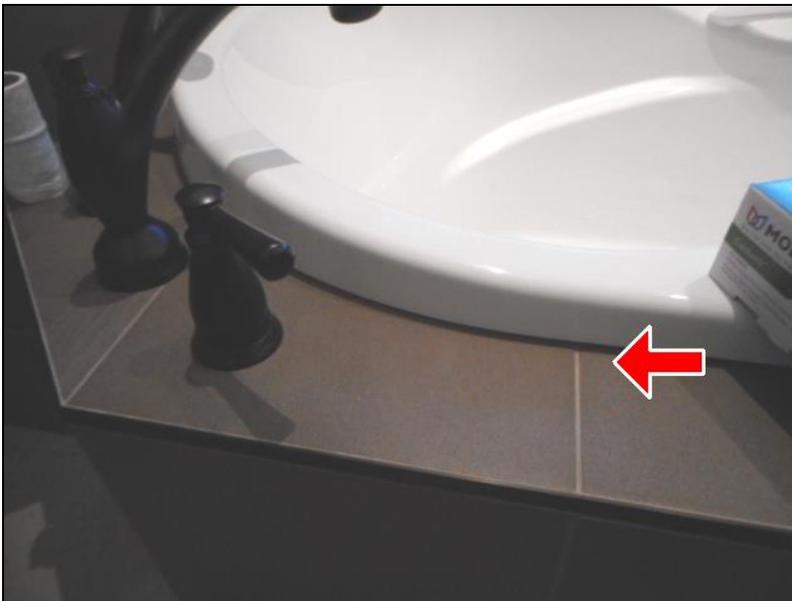
15.9.C Item 1(Picture)

Silicone caulking along floor and inside corners at shower appeared serviceable but recommend silicone caulking around tub as minor preventative maintenance to minimize potential for spilled water migration/damage under tub and to facilitate cleaning.

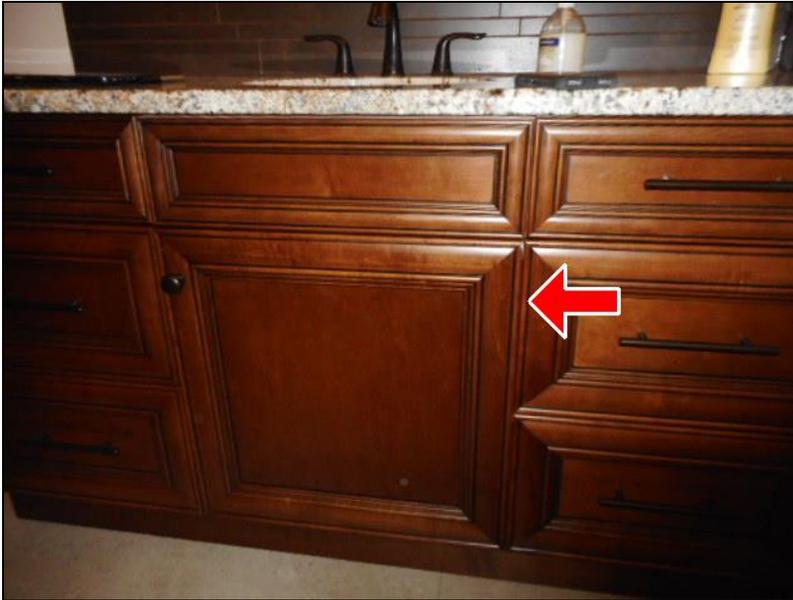
15.0.E Item 1(Picture)

Sink base and cabinetry appeared serviceable and doors/drawers functioned properly except conflict with door/drawers is causing wear. Attempt to adjust door was unsuccessful. Realignment and adjustment of some drawers and door and touching up small damaged area is needed.

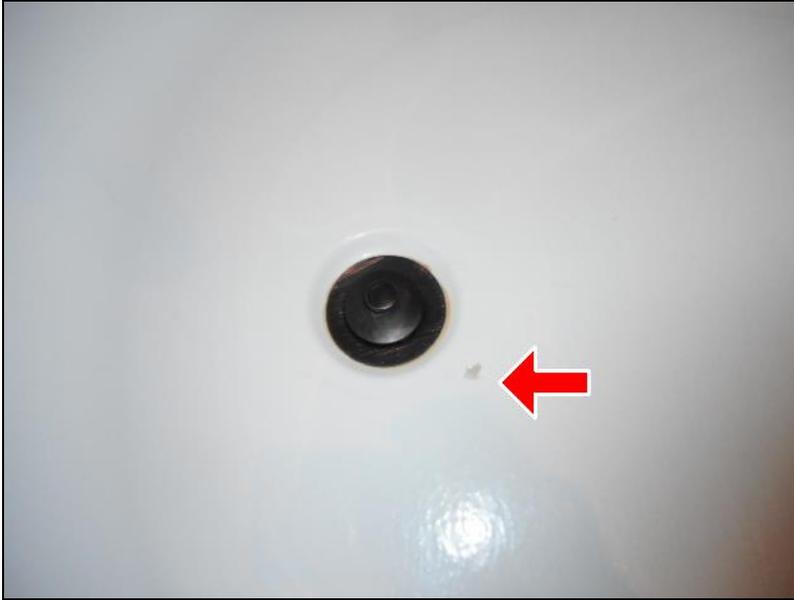
15.2.E Item 1(Picture)

Overall condition of the plumbing fixtures appeared serviceable except the acrylic tub has small chip which will need professional repair.

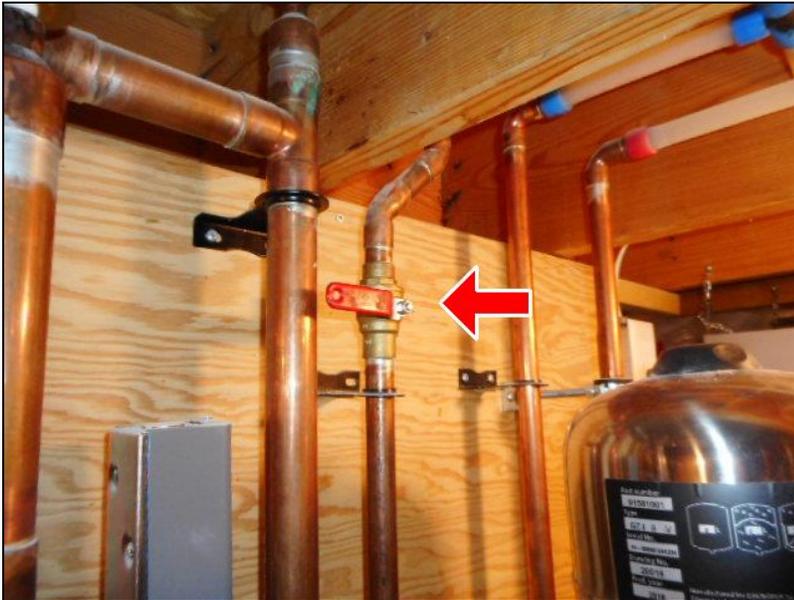
19.0 Item 1(Picture)

Note: This valve and water pump power supply should be shut off whenever the home is vacant for any length of time to minimize damage in the event of a water leak.

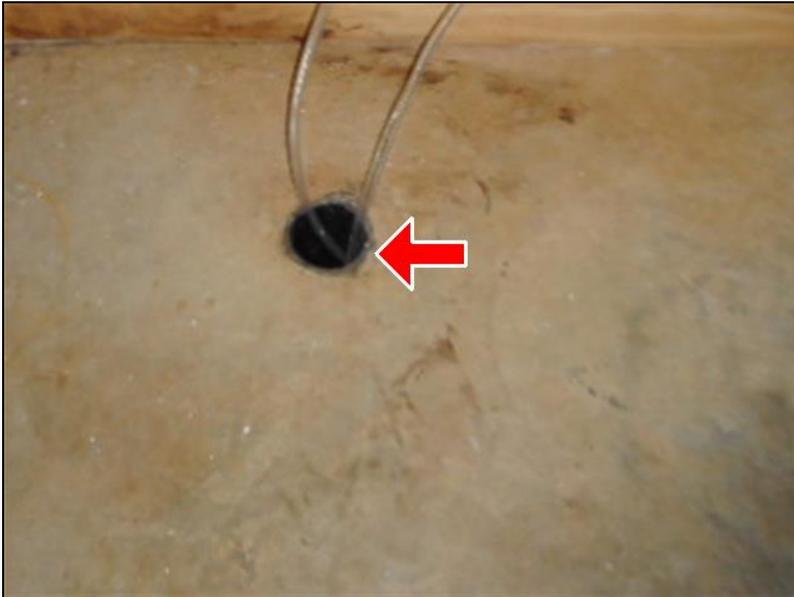
19.13 Item 1(Picture)

Floor drain was found adjacent to water heater but should have a drain cover installed to prevent large objects/debris entering/plugging drain.

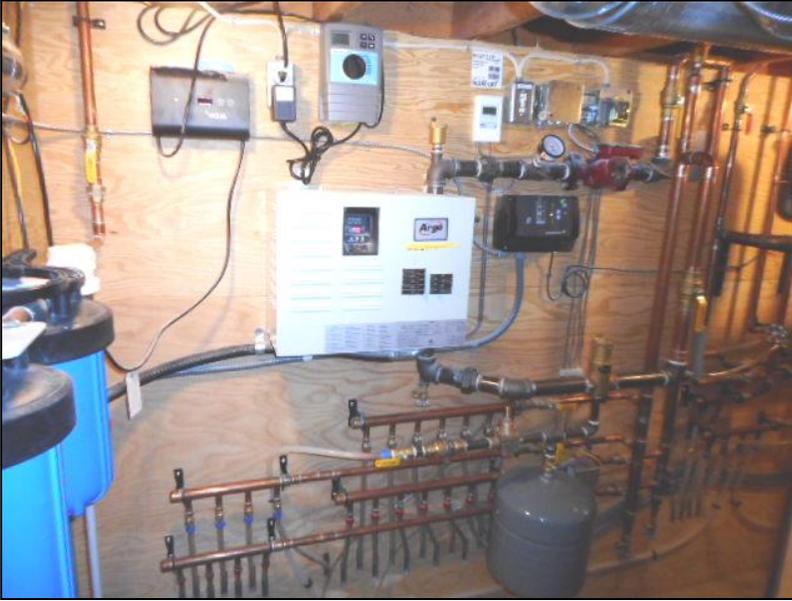
20.4 Item 1(Picture)

The main heating system is a circulating boiler providing heating to main domestic water heater and the hydronic in floor heating equipment system in main floor areas which is a multi zone system. System operated normally and appears in serviceable condition with no concern evident but is complex. A qualified heating contractor familiar with this system should be retained to provide familiarization and operating procedures to owner.

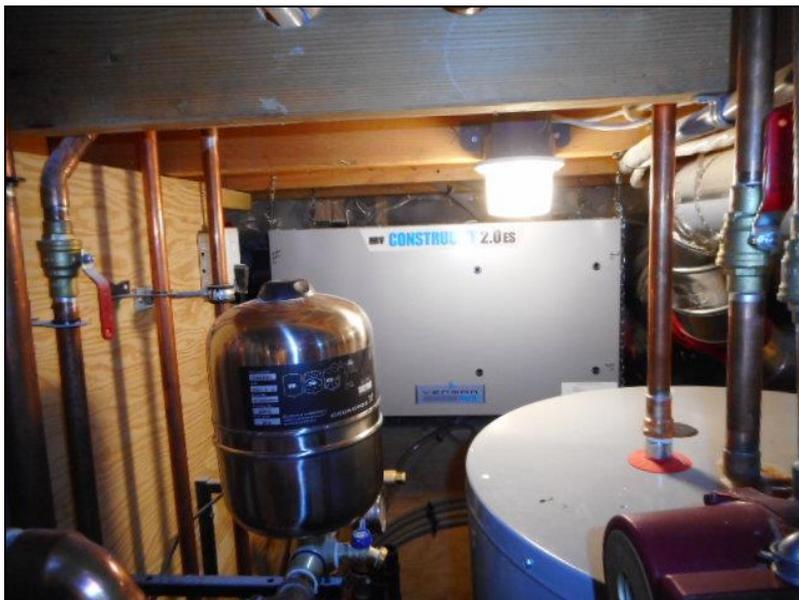
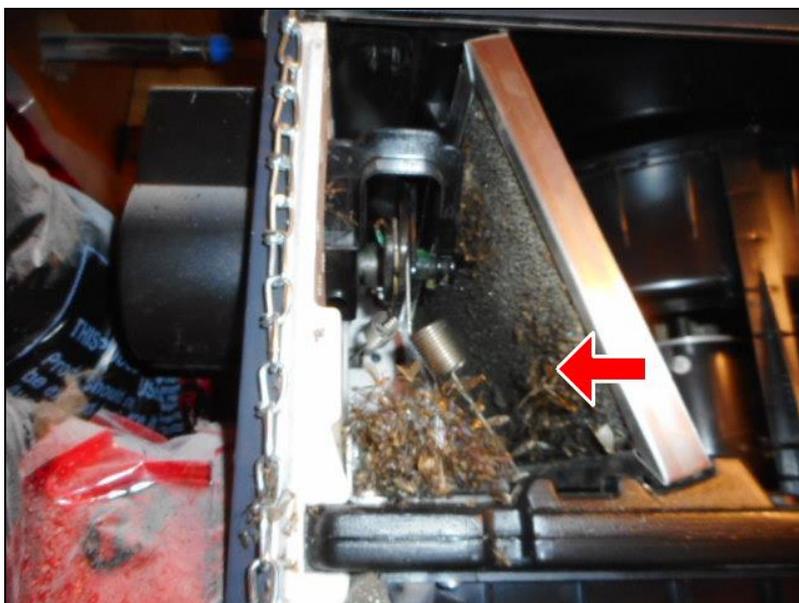
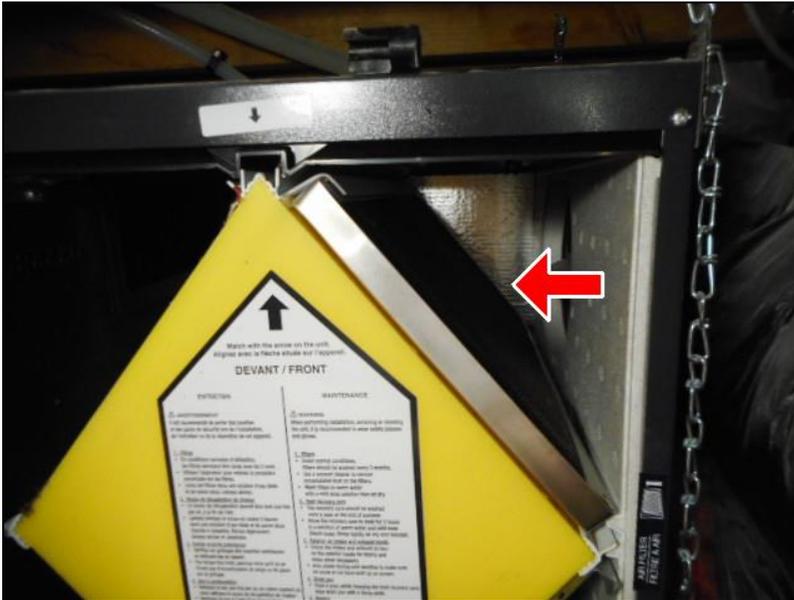
An air to air heat recovery ventilator is installed which functioned normally with no concern evident but filters were dirty need to be cleaned (at red arrows in picture 2). This is normal maintenance which should be done at approximate 3 month intervals.

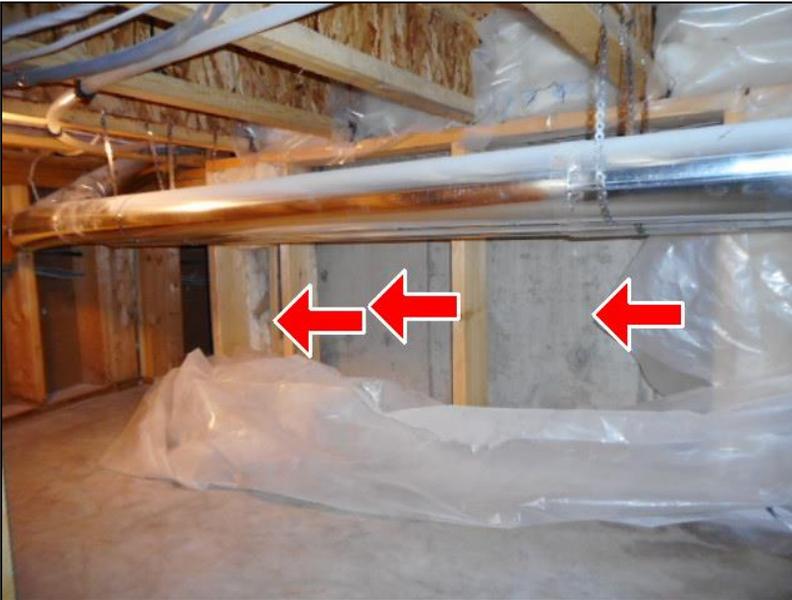
22.7 Item 1(Picture)

Most areas were covered preventing inspection. Foundation had wood framing with vapor barrier and fiberglass insulation installed in finished areas, confirmed at several light switches or outlets chosen randomly and scan with infrared camera except small area of incomplete insulation and vapor barrier needs finishing in crawlspace area.

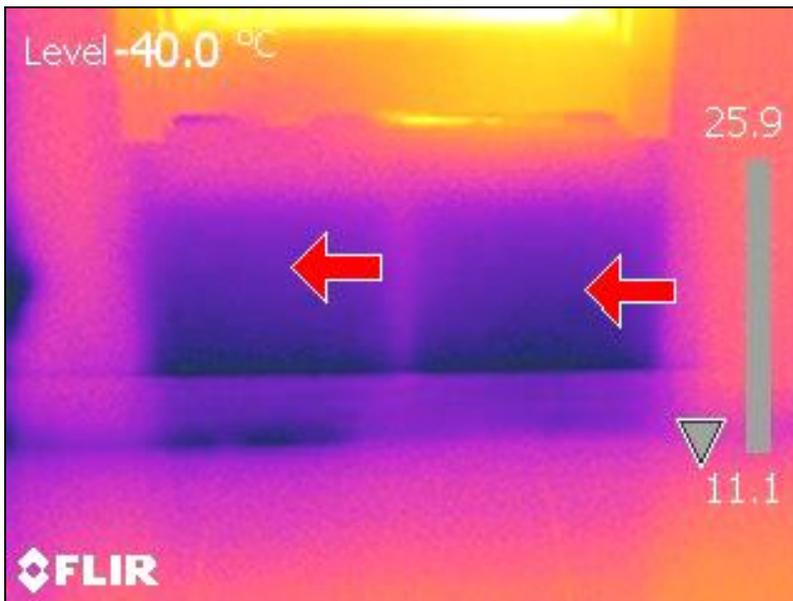
22.8 Item 1(Picture)

All walls were covered restricting inspection. Exterior walls are 2 x 6 wood framed with vapor barrier and fiberglass insulation found by probing with wire at several light switches or outlets chosen randomly and scan with infrared camera except small area of wall below fireplace does not appear to be insulated which could result in condensation and mold growth during cold weather. Installing insulation is needed which will require repairing drywall and repainting area.

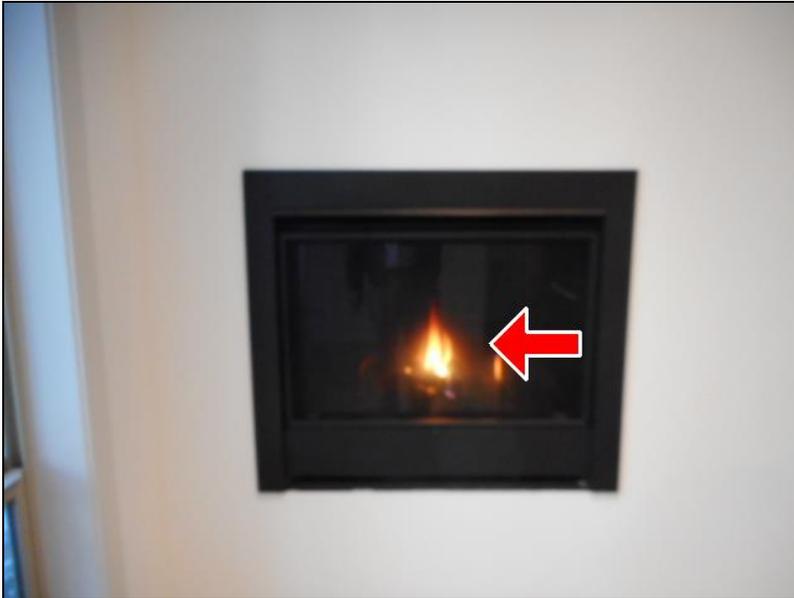
23.0 Item 1(Picture)

Direct vent gas fireplace functioned normally with no concern evident except control is thermostat on wall which functioned normally with no concern evident but fireplace was supplied with remote control device which should be installed per owners preference. Soot/deposits buildup on interior of glass front indicate poor combustion. Recommend a qualified heating contractor service and adjust as required.
