Inspection Report

Property Address:

sample
Sample BC

Homegauge B.C. Ltd.

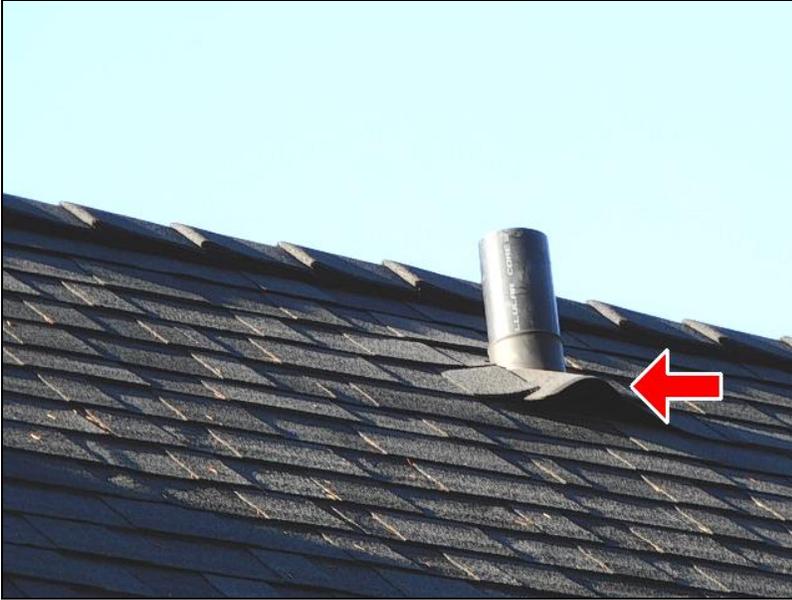
Item 5 - Item 3(Picture)

5. Snow cover obstructed view in some areas preventing proper assessment. Visible areas indicate roofing is installed well overall except a few small areas around roof penetrations need minor repair to lay roofing flat.

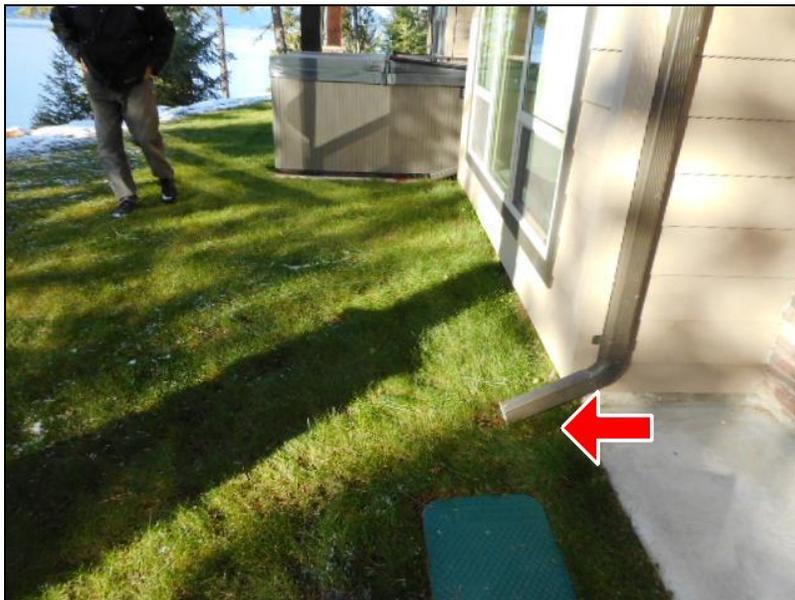
Item 6 - Item 2(Picture)

6. Overall condition of the gutters and downspouts appeared serviceable except discharge is in close proximity to foundations which is undesirable. Downspout extensions should be extended to discharge roof drainage well away from foundation to minimize potential for water accumulation at foundation and infiltration into crawlspace or living area, especially when ground is frozen and snow/ice accumulation may cause damming preventing adequate surface drainage away from home. Please review attachment at end of report.

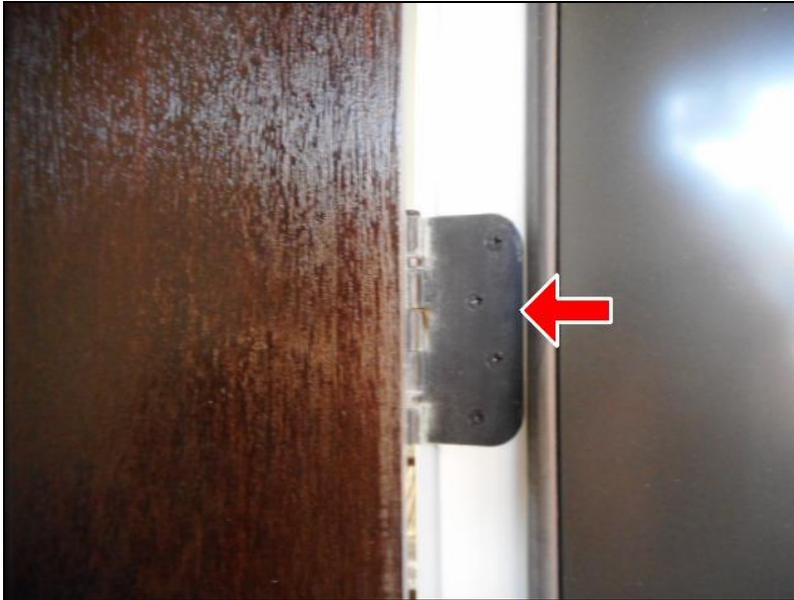
Item 10 - Item 3(Picture)

The entry doors and hardware functioned normally and appeared serviceable except the rear entry doors swing outward which will be prone to wind catching door causing it to open out of control with potential for damage or injury. Installation of a restraining device to limit door swing is recommended (i.e. wind chain/spring at red line in picture).

Installation of long screws to embed into adjacent wood stud is needed to meet building code at deadbolt strike plates and 1 screw in each hinge for improved security and to minimize potential for door sag caused by loosening screws over time.

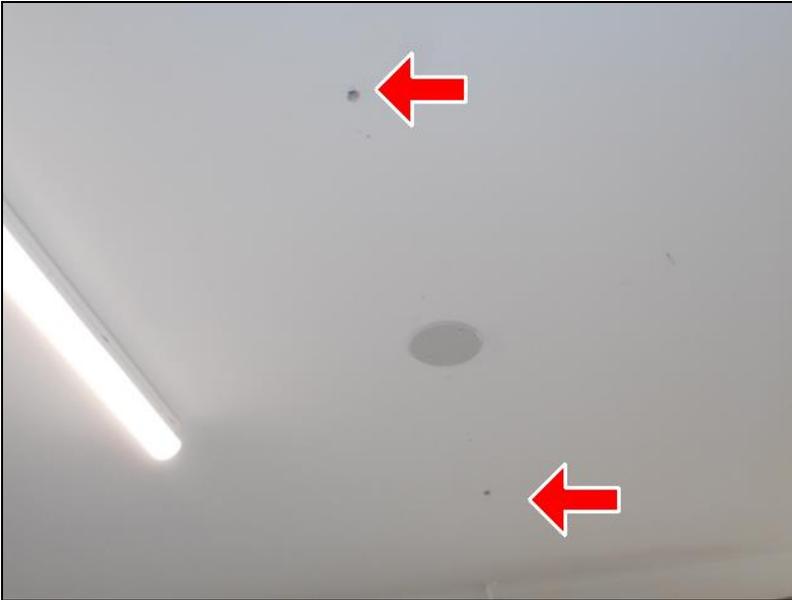
Item 11 - Item 1(Picture)

11. The garage interior appeared serviceable overall except holes at previous light fixture location need to be patched/repainted and water piping penetration of ceiling needs to be sealed to comply with building code requirement for fume separation between garage and living area.

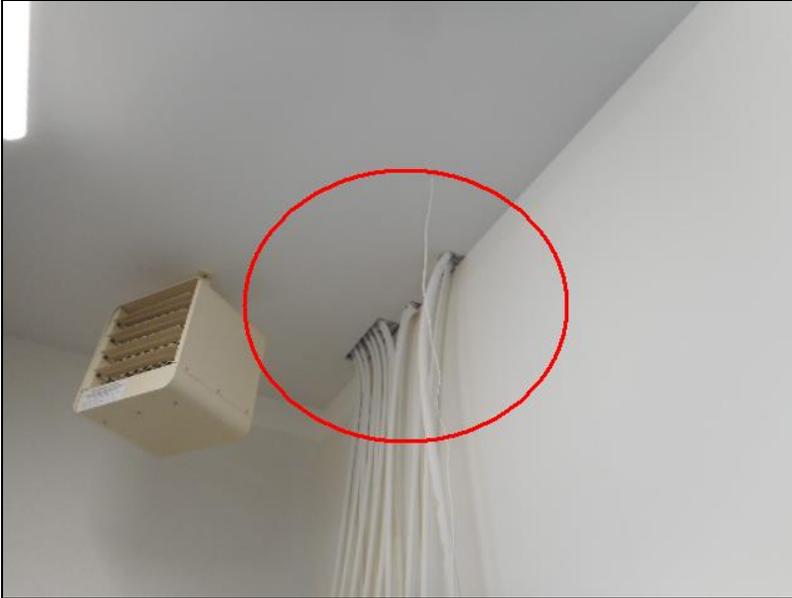
Item 12 - Item 1(Picture)

12. Smoke/fume separation between garage and living areas appeared serviceable overall except plumbing penetration at ceiling needs to be sealed and the door from the garage to the interior of the home requires adjustment of the spring hinges and door hardware to ensure door automatically closes and latches shut to to comply with building code requirement for fume separation between garage and living area.

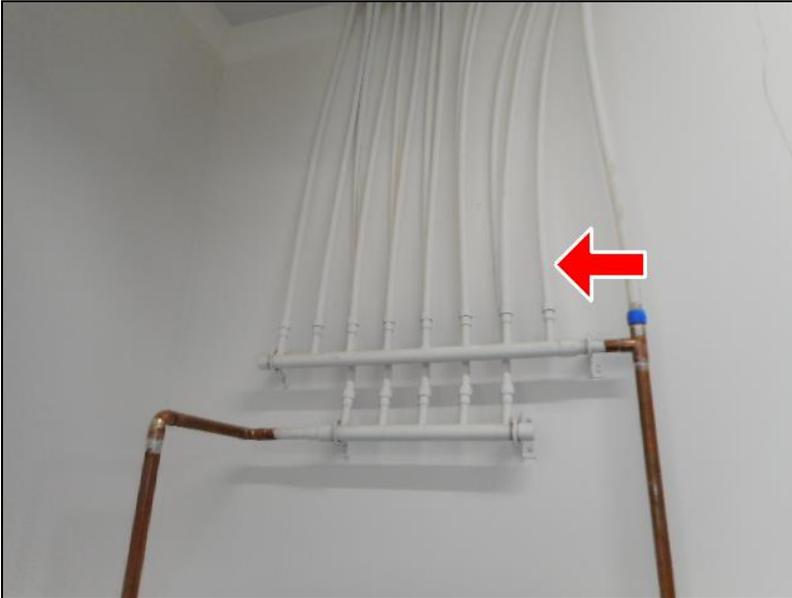
Item 13 - Item 2(Picture)

13. A water heater and exposed plumbing were present. Water heater should remain on during freezing months and garage must be maintained above freezing temperature to prevent frost damage and leaks.

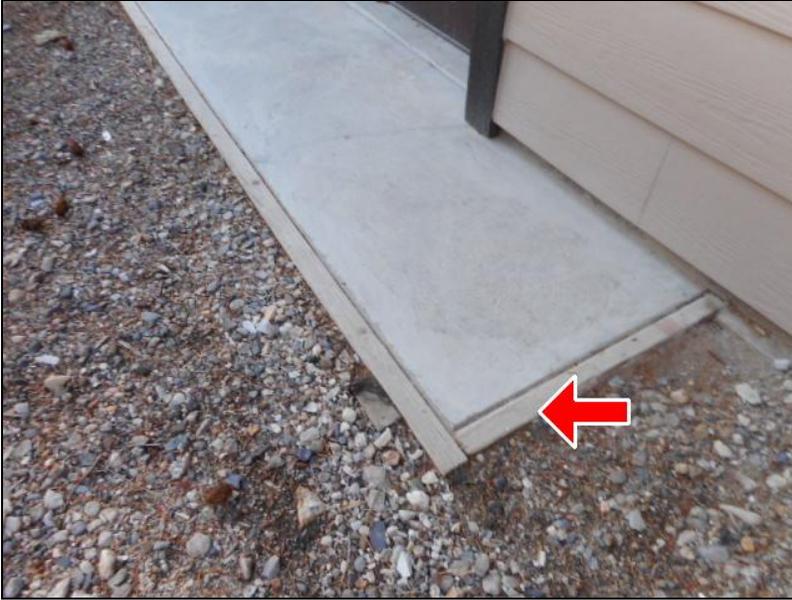
Item 14 - Item 1(Picture)

14. The concrete walkways appeared serviceable overall except the wood form work needs to be removed and gravel finished at garage entry/walkway.

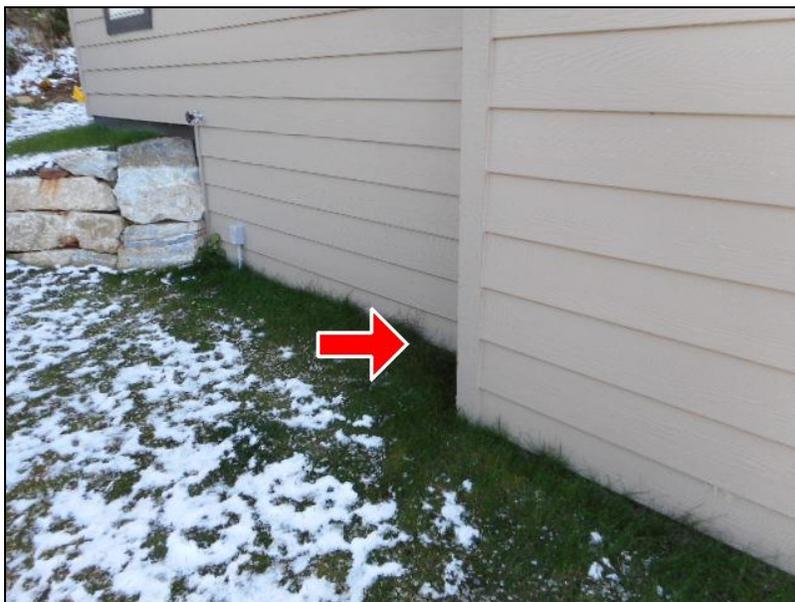
Item 15 - Item 2(Picture)

15. Less than the building code 6" minimum clearance from bottom of wall cladding to finished grade was observed in most areas with roof drainage discharging into areas which is potential concern for water accumulation and leaks into home. Regrading is needed in many areas to ensure adequate clearance from siding to grade to minimize potential for seasonal moisture infiltration, deterioration of cladding and/or structure and insect entry into home. This will require substantial modification/repair of the existing finished landscaping.

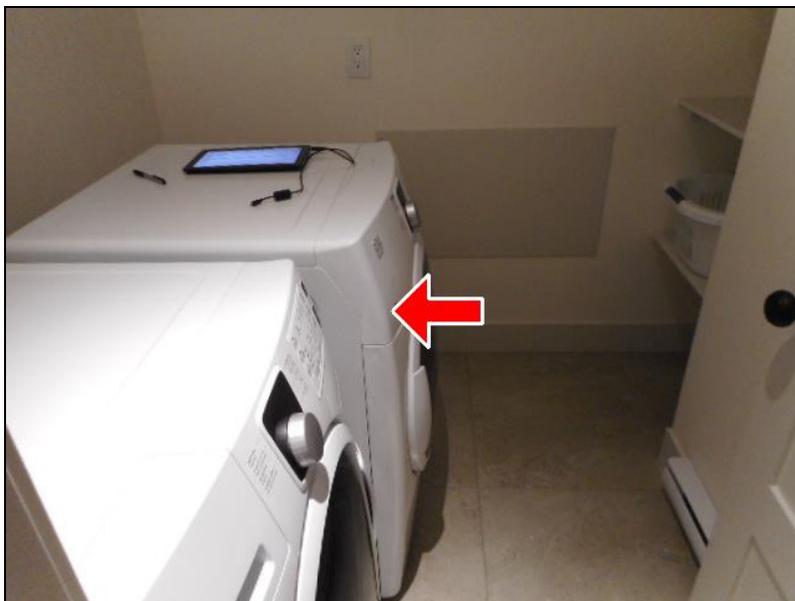
Item 18 - Item 1(Picture)

18. Dryer power appeared serviceable and vents are ducted to exterior vent hoods but the venting in laundry room has been installed within room contrary to plan which show dryer close to wall which would require venting to be recessed in wall which is a common detail. This has forced dryer to be installed out of alignment with washer and approximately 6" forward which encroaches on limited space in this room. Correction to comply with drawings will require wall and exterior modifications and refinishing.

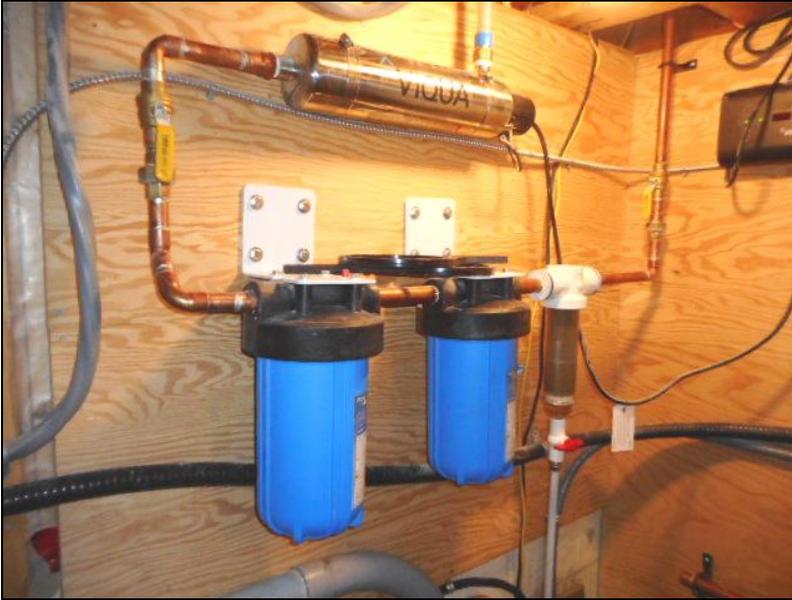
Item 25 - Item 1(Picture)

Sediment filters and UV sterilizer were present. No obvious concern was evident but we do not test this type of equipment. Regular filter changes will be needed.

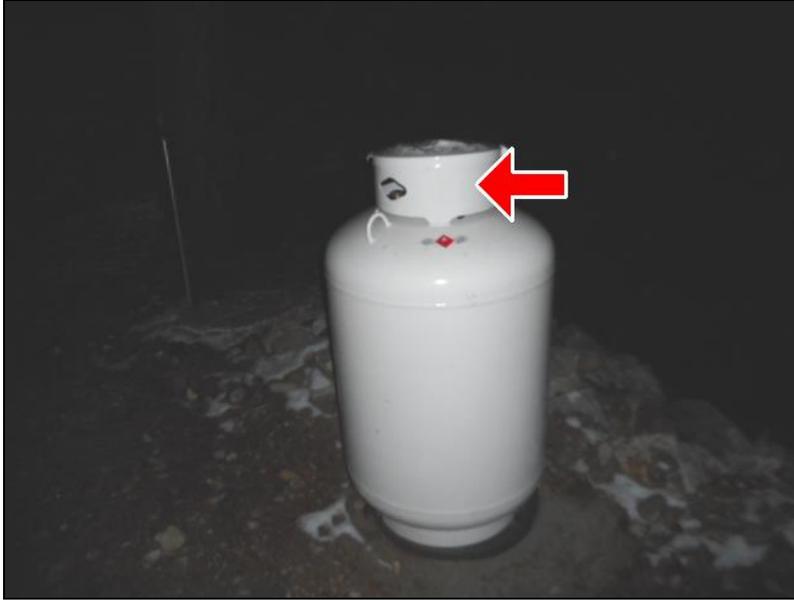
Item 27 - Item 1(Picture)

27. The propane service entry and storage tank appeared serviceable overall with no concern evident. Main emergency shutoff valve is at tank at red arrow in picture.

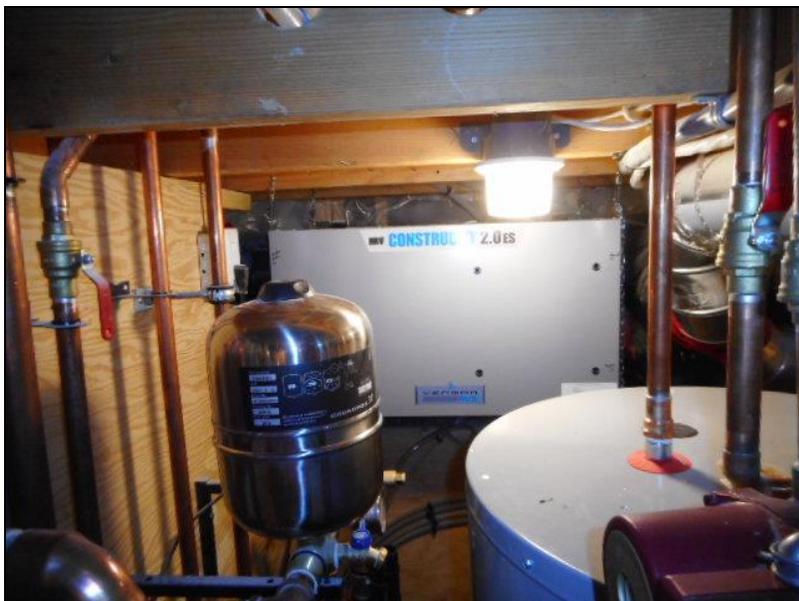
Item 29 - Item 1(Picture)

29. An air to air heat recovery ventilator is installed which functioned normally with no concern evident but filters were dirty need to be cleaned (at red arrows in picture 2). This is normal maintenance which should be done at approximate 3 month intervals.

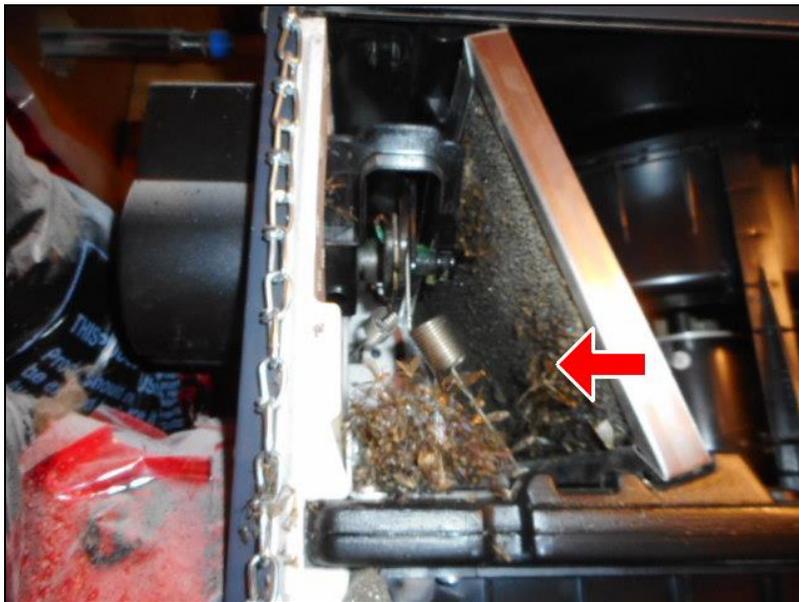
Item 29 - Item 2(Picture)

An air to air heat recovery ventilator is installed which functioned normally with no concern evident but filters were dirty need to be cleaned (at red arrows in picture 2). This is normal maintenance which should be done at approximate 3 month intervals.

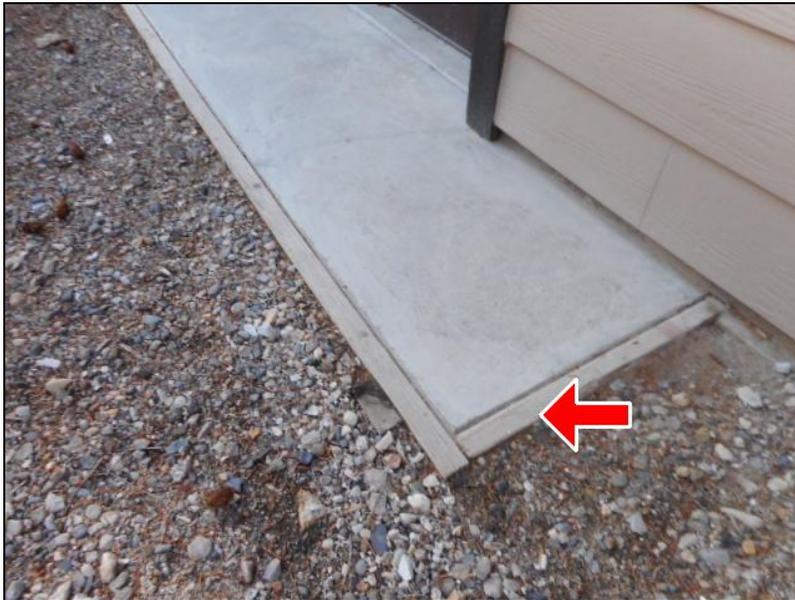
7.0 Item 1(Picture)

The concrete walkways appeared serviceable overall except the wood form work needs to be removed and gravel finished at garage entry/walkway.

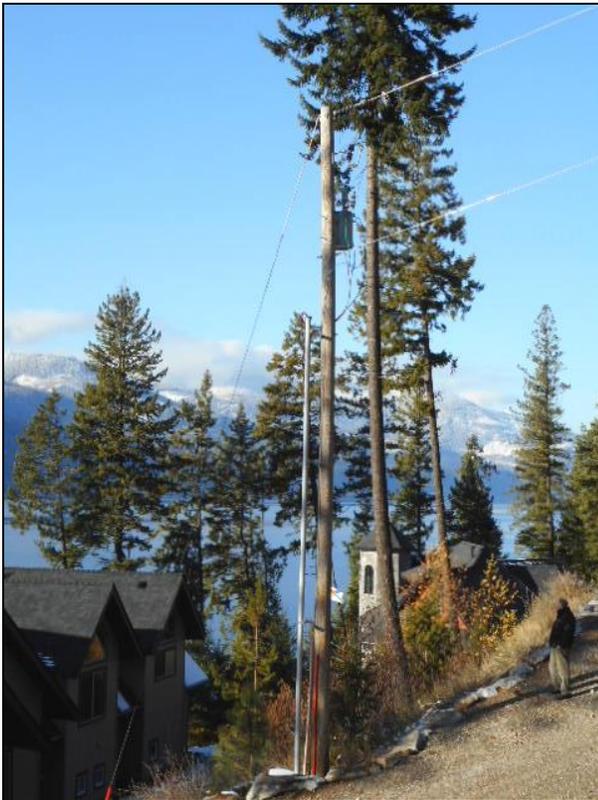
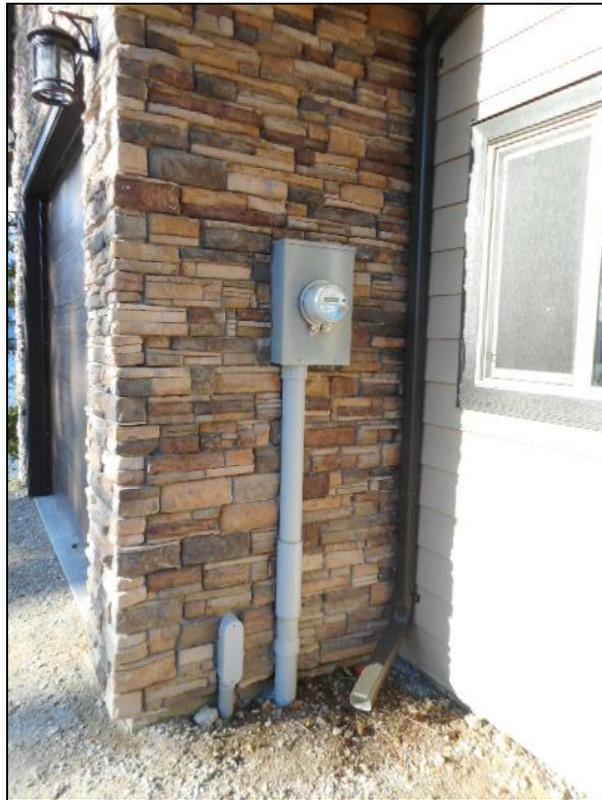
Complimentary view of electrical service entry which appeared serviceable overall with no concern observed.

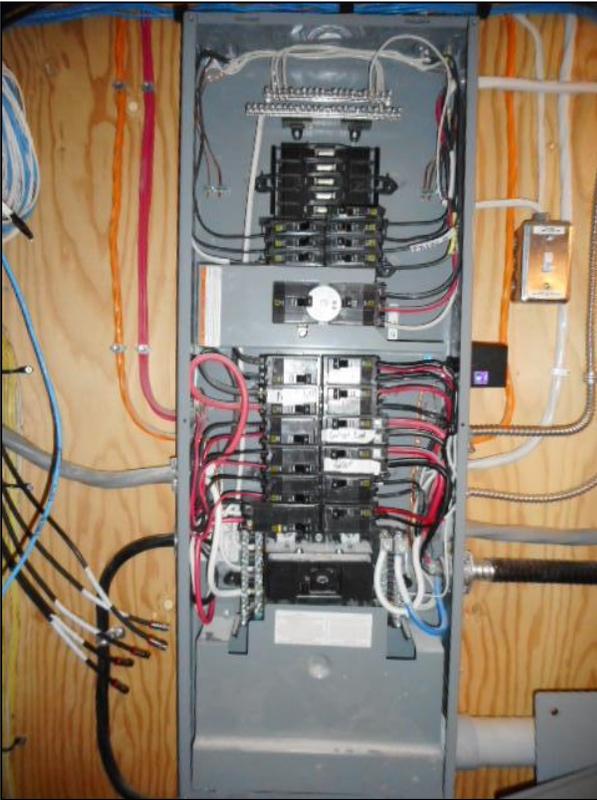
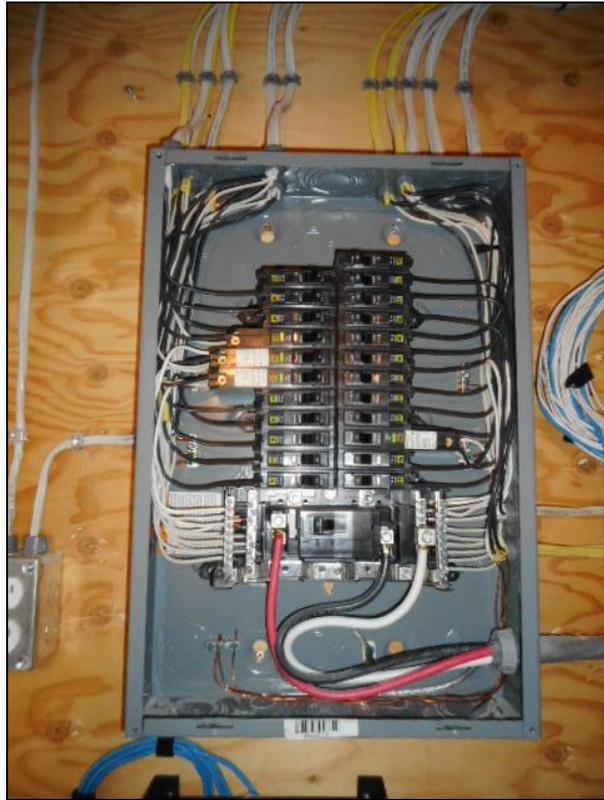
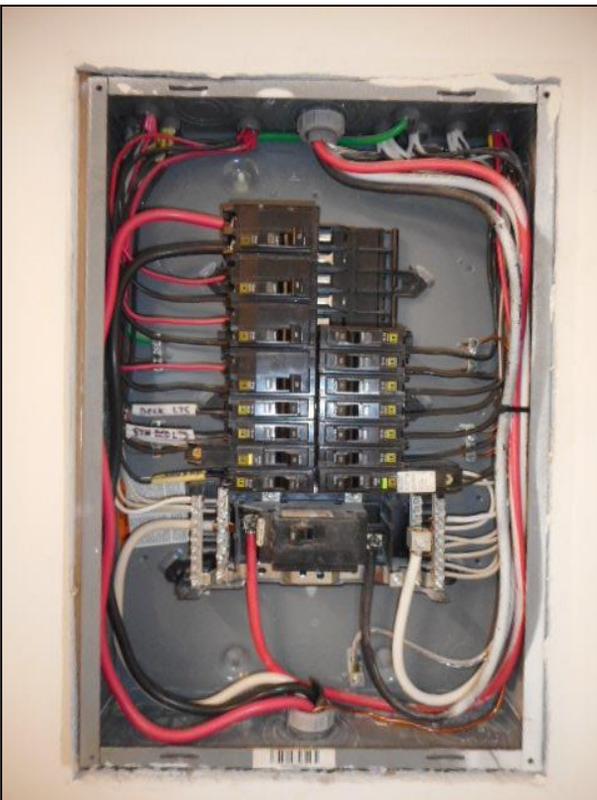
Complimentary view of wiring inside distribution panels which appeared serviceable and original with no sign of alterations or additions. No concern was observed.

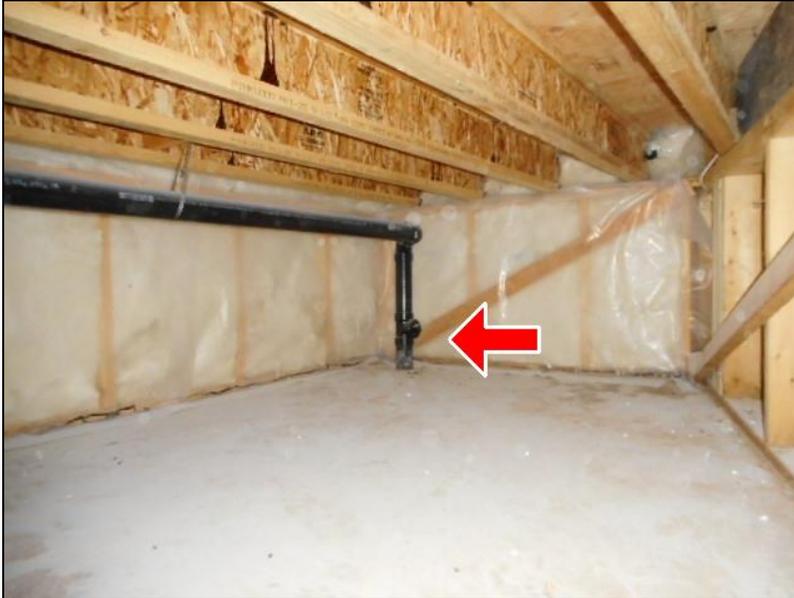
19.5 Item 1(Picture)

Complimentary view of 4" ABS plastic main waste line and cleanout in crawlspace to allow plumber access to clear waste line with no concern observed.

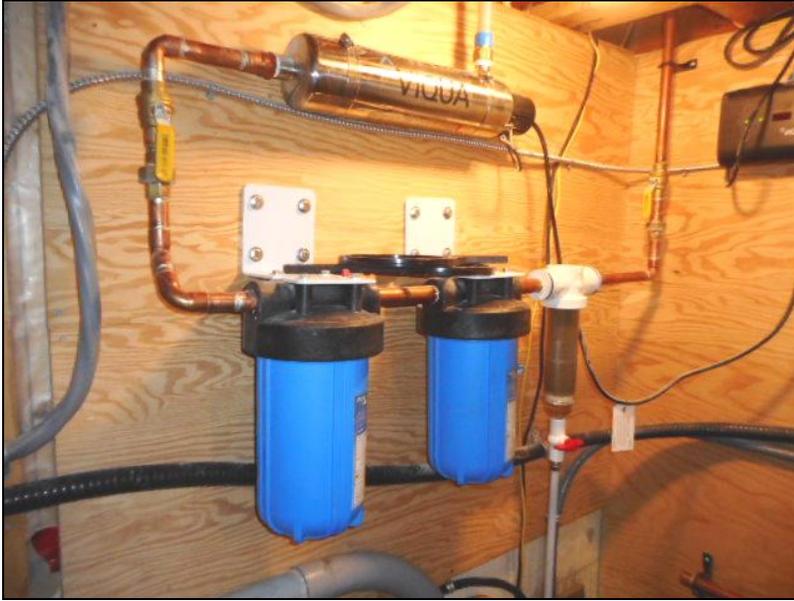
19.11 Item 1(Picture)

Sediment filters and UV sterilizer were present. No obvious concern was evident but we do not test this type of equipment. Regular filter changes will be needed.

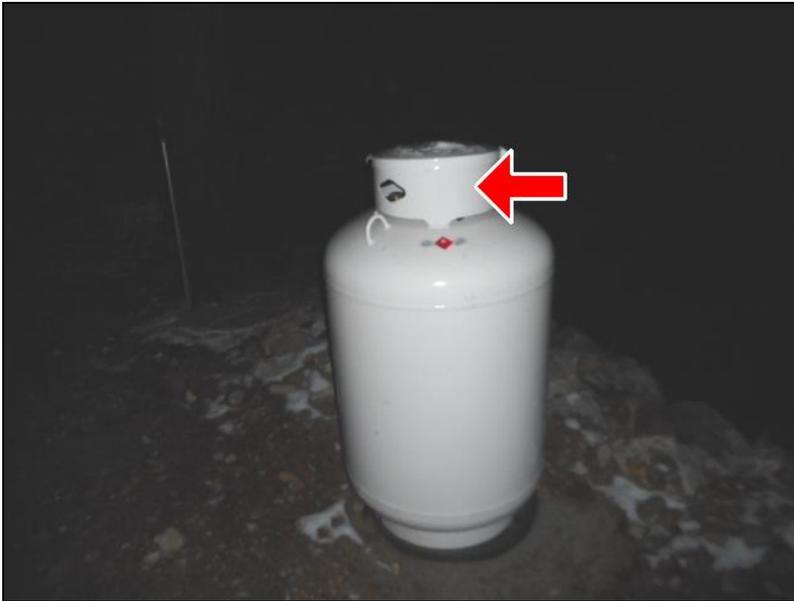
20.0 Item 1(Picture)

The propane service entry and storage tank appeared serviceable overall with no concern evident. Main emergency shutoff valve is at tank at red arrow in picture.
